Intersection ID: 17663	Main Street: TRANQUIL_AV	Cross Street: WESTFIELD_RD	Location:	W
ADA ID: 201AE61FC2CC	Ramp Type: BlendTrans2	Initial Pass/Fail: Fail	Overall Compliance: No	Severity Score: 21.25

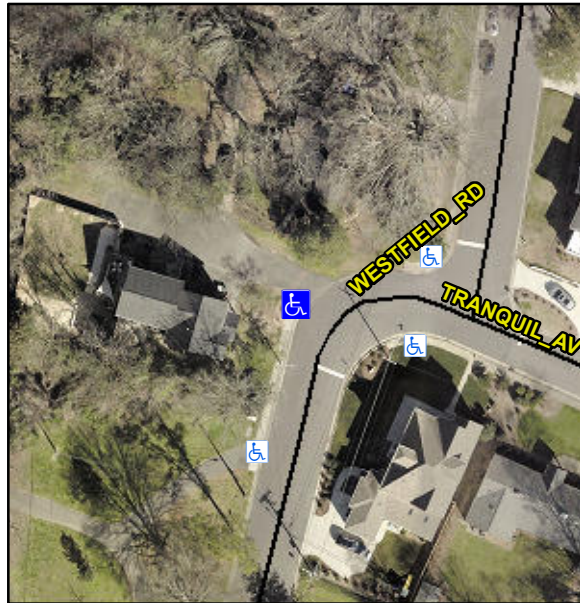
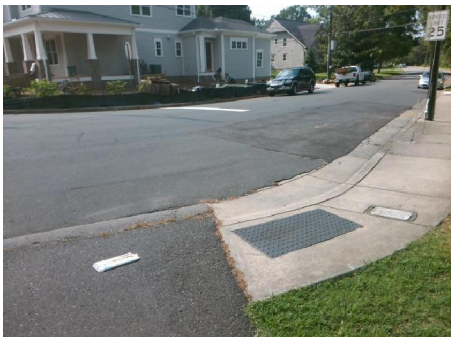
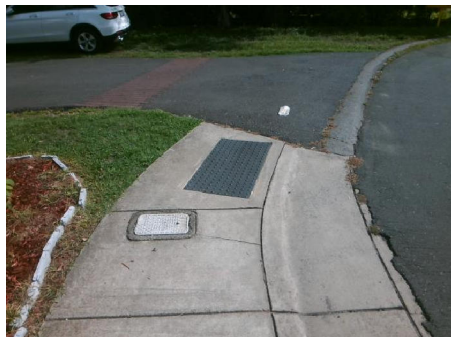
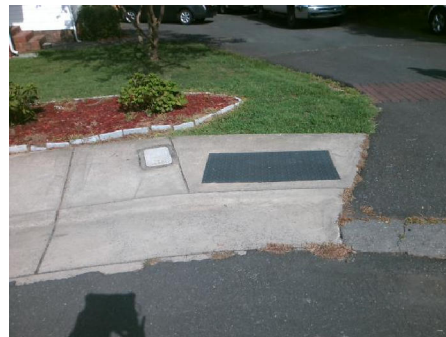
Not Found, R304.5.1, R304.5.3

Compliance	Description	Data	Compliance	Description	Data
N/A	Ramp Length (in)	48.0	Yes	BlendTrans Slope (%)	2.2
No	Ramp Width (in)	41.0	No	BlendTrans XSlope (%)	5.5
N/A	Flare Type LT	N/A	N/A	Flare Type RT	N/A
N/A	Flare Slope LT (%)	N/A	N/A	Flare Slope RT (%)	N/A
N/A	Flare Traversable LT?	N/A	N/A	Flare Traversable RT?	N/A
N/A	Landing Length (in)	N/A	N/A	DWS Provided?	N/A
N/A	Landing Width (in)	N/A	N/A	DWS Contrast?	N/A
N/A	Landing Slope (%)	N/A	N/A	DWS Length (in)	N/A
N/A	Landing X Slope (%)	N/A	N/A	DWS Full Width?	N/A
N/A	Landing Curb? (Y/N)	N/A	N/A	DWS Offset (in)	N/A
N/A	Shared Landing?	N/A			
N/A	Gutter Ponding?	N/A	N/A	Gutter Slope (%)	N/A
N/A	Gutter Lip Ht (in)	N/A	N/A	Gutter X Slope (%)	N/A
N/A	Painted X Walk1?	No	N/A	Painted X Walk2?	N/A
	X Walk 1 Direction	To SE		X Walk 2 Direction	N/A
	X Walk 1 Width (in)	N/A		X Walk 2 Width (in)	N/A
	X Walk 1 Slope (%)	5.0		X Walk 2 Slope (%)	N/A
	X Walk 1 X Slope (%)	1.6		X Walk 2 X Slope (%)	N/A

N/A	Ramp inside XWalk1?	N/A	N/A	Ramp inside XWalk2?	N/A
	Road Slope (%)	1.6		Clear Space?	N/A
	Road X Slope (%)	5.0	N/A	Clear Space to XWalk (in)	N/A
N/A	Any Obstructions?	N/A	N/A	Storm Grate/Utility Hazard?	N/A
	Obstruction Type			Storm Grate/Utility Type	
		N/A			N/A
			Yes	Surface Condition? (G/P)	Good
			No	Curb Slope (%)	6.9

Remove & Replace Curb Ramp With Two New Directional Ramps or Equivalent.

Total Cost: \$ 3200.00
