Access Compliance Report

Public Rights-of-Way

(Curb Ramps)

Intersection ID: 14692	Main Street: QUEENS_RD	Cross Street: DARTMOUTH_PL	Location: S
ADA ID: 201D77B8CDCC	Ramp Type: Perp	Initial Pass/Fail: Fail	Overall Compliance: No
Codes/Mitigation Info/Possible Solution			Severity Score: 37.5
			Field Measurements/Component Compliance

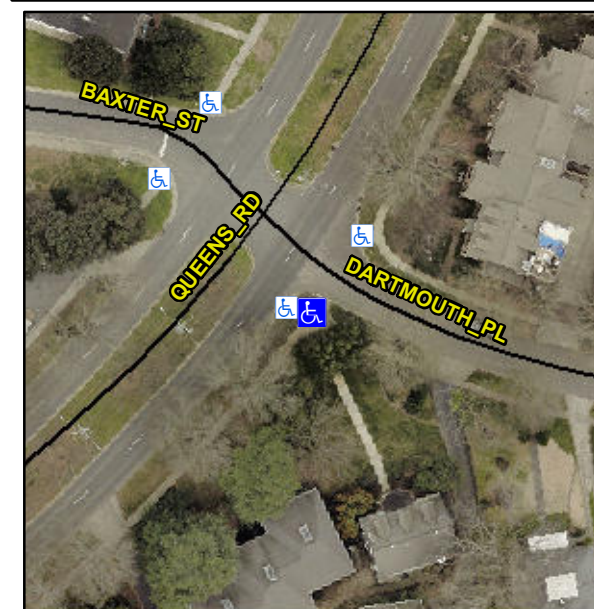
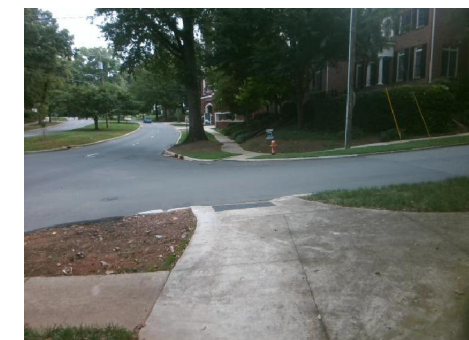
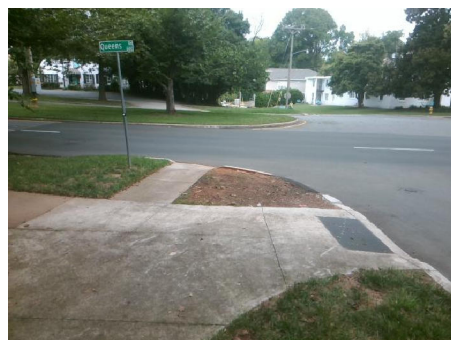
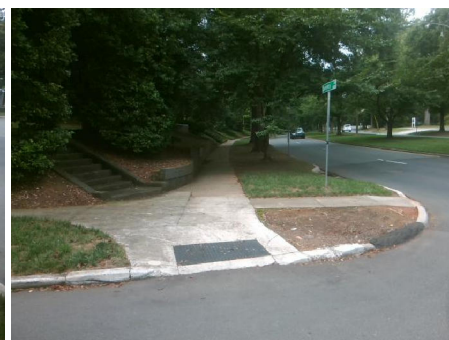
Not Found, R304.2.2, R304.5.3

Compliance	Description	Data	Compliance	Description	Data
N/A	Ramp Length (in)	58.5	No	Ramp Slope (%)	9.8
Yes	Ramp Width (in)	48.0	No	Ramp XSlope (%)	7.1
N/A	Flare Type LT	N/A	N/A	Flare Type RT	N/A
N/A	Flare Slope LT (%)	N/A	N/A	Flare Slope RT (%)	N/A
N/A	Flare Traversable LT?	N/A	N/A	Flare Traversable RT?	N/A
N/A	Landing Length (in)	N/A	N/A	DWS Provided?	N/A
N/A	Landing Width (in)	N/A	N/A	DWS Contrast?	N/A
N/A	Landing Slope (%)	N/A	N/A	DWS Length (in)	N/A
N/A	Landing X Slope (%)	N/A	N/A	DWS Full Width?	N/A
N/A	Landing Curb? (Y/N)	N/A	N/A	DWS Offset (in)	N/A
N/A	Shared Landing?	N/A			
N/A	Gutter Ponding?	N/A	N/A	Gutter Slope (%)	N/A
N/A	Gutter Lip Ht (in)	N/A	N/A	Gutter X Slope (%)	N/A
N/A	Painted X Walk1?	No	N/A	Painted X Walk2?	N/A
	X Walk 1 Direction	To NE		X Walk 2 Direction	N/A
N/A	X Walk 1 Width (in)	N/A	N/A	X Walk 2 Width (in)	N/A
	X Walk 1 Slope (%)	0.4		X Walk 2 Slope (%)	N/A
	X Walk 1 X Slope (%)	5.4		X Walk 2 X Slope (%)	N/A

N/A	Ramp inside XWalk1?	N/A	N/A	Ramp inside XWalk2?	N/A
	Road Slope (%)	N/A	N/A	Clear Space?	N/A
	Road X Slope (%)	N/A	N/A	Clear Space to XWalk (in)	N/A
N/A	Any Obstructions?	N/A	N/A	Storm Grate/Utility Hazard?	N/A
	Obstruction Type			Storm Grate/Utility Type	
		N/A			N/A
			Yes	Surface Condition? (G/P)	Good

Remove & Replace Entire Ramp.
