Access Compliance Report

Public Rights-of-Way (Curb Ramps)

Intersection ID: 48763	Main Street: SONOMA_VALLEY_DR	Cross Street: N/A	Location: S
ADA ID: 201F74C95CAF	Ramp Type: Perp	Initial Pass/Fail: Fail	Overall Compliance: No
		Severity Score: 12.5

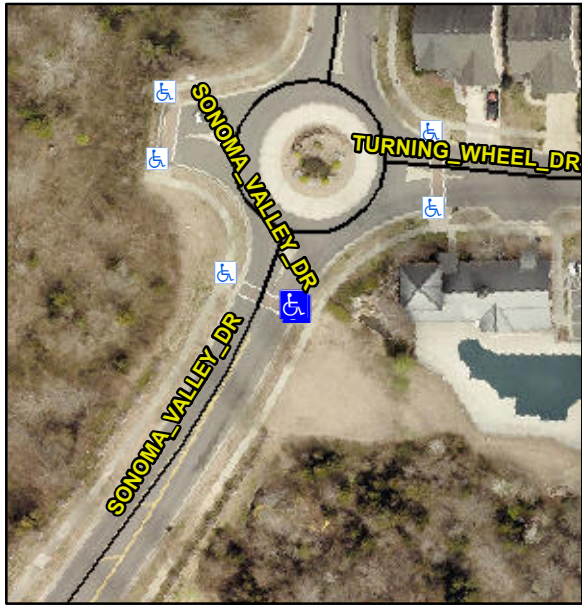
Possible Solutions:		Compliance	Description	Data	Compliance	Description	Data
	Remove & Replace Entire Ramp.		N/A	Ramp Length (in)	72.0	No	Ramp Slope (%)	9.2
			Yes	Ramp Width (in)	48.0	Yes	Ramp XSlope (%)	0.0
			N/A	Flare Type LT	N/A	N/A	Flare Type RT	N/A
			N/A	Flare Slope LT (%)	N/A	N/A	Flare Slope RT (%)	N/A
			N/A	Flare Traversable LT?	N/A	N/A	Flare Traversable RT?	N/A
			N/A	Landing Length (in)	N/A	N/A	DWS Provided?	N/A
			N/A	Landing Width (in)	N/A	N/A	DWS Contrast?	N/A
			N/A	Landing Slope (%)	N/A	N/A	DWS Length (in)	N/A
			N/A	Landing X Slope (%)	N/A	N/A	DWS Full Width?	N/A
Surveyor Notes:	N/A		N/A	Landing Curb? (Y/N)	N/A	N/A	DWS Offset (in)	N/A
			N/A	Shared Landing?	N/A			
	PROW/ADA:		N/A	Gutter Ponding?	N/A	N/A	Gutter Slope (%)	N/A
	Not Found, R304.2.2		N/A	Gutter Lip Ht (in)	N/A	N/A	Gutter X Slope (%)	N/A

N/A	Painted X Walk1?	Yes	N/A	Painted X Walk2?	N/A
				X Walk 1 Direction	To NW		X Walk 2 Direction	N/A
			N/A	X Walk 1 Width (in)	75.0	N/A	X Walk 2 Width (in)	N/A
				X Walk 1 Slope (%)	0.9		X Walk 2 Slope (%)	N/A
				X Walk 1 X Slope (%)	1.3		X Walk 2 X Slope (%)	N/A
			N/A	Ramp inside XWalk1?	Yes	N/A	Ramp inside XWalk2?	N/A
				Road Slope (%)	N/A	N/A	Clear Space?	N/A
				Road X Slope (%)	N/A	N/A	Clear Space to XWalk (in)	N/A
			N/A	Any Obstructions?	N/A	N/A	Storm Grate/Utility Hazard?	N/A
				Obstruction Type			Storm Grate/Utility Type	
					N/A			N/A
						Yes	Surface Condition? (G/P)	Good
Total Cost:		\$	1850.00
