Access Compliance Report

Public Rights-of-Way

(Curb Ramps)

Intersection ID: 50584	Main Street: GREAT_LAUREL_RD	Cross Street: GRAND_FIR_RD	Location: W
ADA ID: 2021A3E1BB8B	Ramp Type: Perp	Initial Pass/Fail: Fail	Overall Compliance: No
Severity Score: 10			
Codes/Mitigation Info/Possible Solution		Field Measurements/Component Compliance

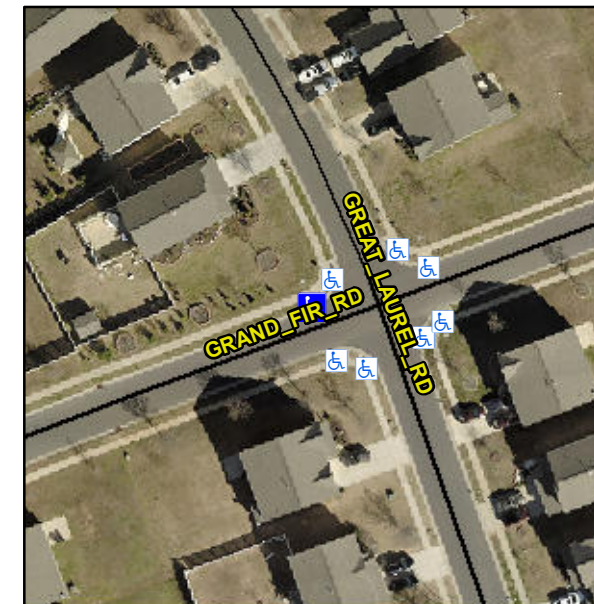
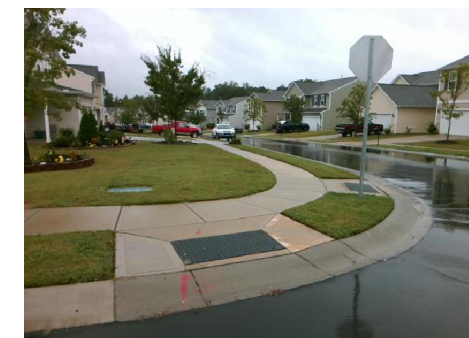
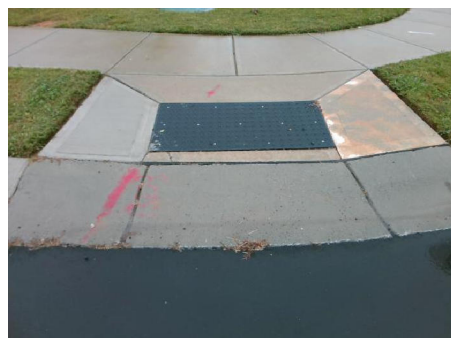
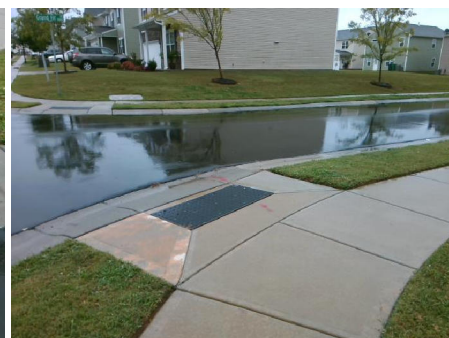
Not Found, R304.5.1, R304.5.3

Compliance	Description	Data	Compliance	Description	Data
N/A	Ramp Length (in)	49.5	Yes	Ramp Slope (%)	6.8
No	Ramp Width (in)	47.0	No	Ramp XSlope (%)	2.6
N/A	Flare Type LT	N/A	N/A	Flare Type RT	N/A
N/A	Flare Slope LT (%)	N/A	N/A	Flare Slope RT (%)	N/A
N/A	Flare Traversable LT?	N/A	N/A	Flare Traversable RT?	N/A
N/A	Landing Length (in)	N/A	N/A	DWS Provided?	N/A
N/A	Landing Width (in)	N/A	N/A	DWS Contrast?	N/A
N/A	Landing Slope (%)	N/A	N/A	DWS Length (in)	N/A
N/A	Landing X Slope (%)	N/A	N/A	DWS Full Width?	N/A
N/A	Landing Curb? (Y/N)	N/A	N/A	DWS Offset (in)	N/A
N/A	Shared Landing?	N/A			
N/A	Gutter Ponding?	N/A	N/A	Gutter Slope (%)	N/A
N/A	Gutter Lip Ht (in)	N/A	N/A	Gutter X Slope (%)	N/A
N/A	Painted X Walk1?	No	N/A	Painted X Walk2?	N/A
	X Walk 1 Direction	To S		X Walk 2 Direction	N/A
N/A	X Walk 1 Width (in)	N/A	N/A	X Walk 2 Width (in)	N/A
	X Walk 1 Slope (%)	1.6		X Walk 2 Slope (%)	N/A
	X Walk 1 X Slope (%)	0.1		X Walk 2 X Slope (%)	N/A

N/A	Ramp inside XWalk1?	N/A	N/A	Ramp inside XWalk2?	N/A
	Road Slope (%)	N/A	N/A	Clear Space?	N/A
	Road X Slope (%)	N/A	N/A	Clear Space to XWalk (in)	N/A
N/A	Any Obstructions?	N/A	N/A	Storm Grate/Utility Hazard?	N/A
	Obstruction Type			Storm Grate/Utility Type	
		N/A			N/A
			Yes	Surface Condition? (G/P)	Good

Remove & Replace Entire Ramp.
