Intersection ID: 10019990	Main Street: ARMORY_DR	Cross Street: N/A	Location:	SE
ADA ID: 20354E9CF18A	Ramp Type: Perp	Initial Pass/Fail: Fail	Overall Compliance: No	Severity Score: 12.5

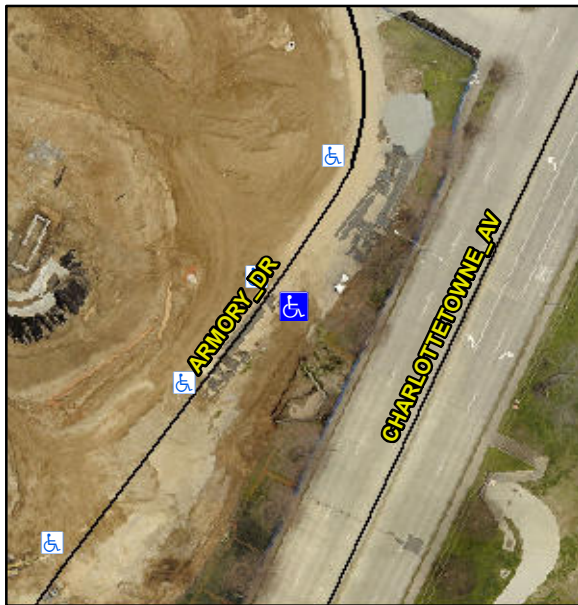
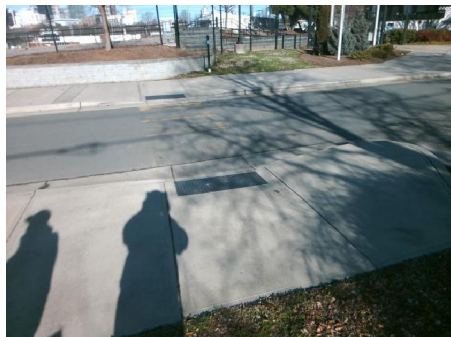
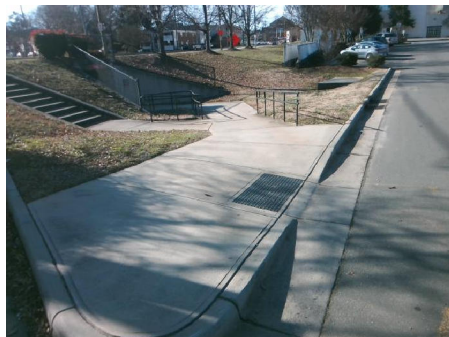
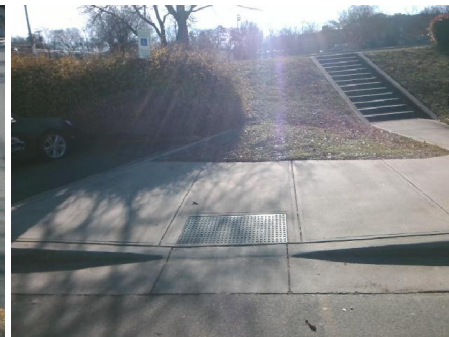
Not Found, R304.2.2

Compliance	Description	Data	Compliance	Description	Data
N/A	Ramp Length (in)	48.0	No	Ramp Slope (%)	8.9
Yes	Ramp Width (in)	48.0	Yes	Ramp XSlope (%)	2.0
N/A	Flare Type LT	N/A	N/A	Flare Type RT	N/A
N/A	Flare Slope LT (%)	N/A	N/A	Flare Slope RT (%)	N/A
N/A	Flare Traversable LT?	N/A	N/A	Flare Traversable RT?	N/A
N/A	Landing Length (in)	N/A	N/A	DWS Provided?	N/A
N/A	Landing Width (in)	N/A	N/A	DWS Contrast?	N/A
N/A	Landing Slope (%)	N/A	N/A	DWS Length (in)	N/A
N/A	Landing X Slope (%)	N/A	N/A	DWS Full Width?	N/A
N/A	Landing Curb? (Y/N)	N/A	N/A	DWS Offset (in)	N/A
N/A	Shared Landing?	N/A			
N/A	Gutter Ponding?	N/A	N/A	Gutter Slope (%)	N/A
N/A	Gutter Lip Ht (in)	N/A	N/A	Gutter X Slope (%)	N/A
N/A	Painted X Walk1?	Yes	N/A	Painted X Walk2?	N/A
	X Walk 1 Direction	To NW		X Walk 2 Direction	N/A
N/A	X Walk 1 Width (in)	72.0	N/A	X Walk 2 Width (in)	N/A
	X Walk 1 Slope (%)	3.8		X Walk 2 Slope (%)	N/A
	X Walk 1 X Slope (%)	2.5		X Walk 2 X Slope (%)	N/A

N/A	Ramp inside XWalk1?	Yes	N/A	Ramp inside XWalk2?	N/A
	Road Slope (%)	N/A	N/A	Clear Space?	N/A
	Road X Slope (%)	N/A	N/A	Clear Space to XWalk (in)	N/A
N/A	Any Obstructions?	N/A	N/A	Storm Grate/Utility Hazard?	N/A
	Obstruction Type			Storm Grate/Utility Type	
		N/A			N/A
			Yes	Surface Condition? (G/P)	Good

Remove & Replace Entire Ramp.

Total Cost: \$ 1850.00
