Access Compliance Report

Public Rights-of-Way

(Curb Ramps)

Intersection ID: 14434	Main Street: E_5TH_ST	Cross Street: RIDGEWAY_AV	Location: NE
ADA ID: 203BA270C64E	Ramp Type: PerpDiag	Initial Pass/Fail: Fail	Overall Compliance: No
Severity Score: 1.25			
Codes/Mitigation Info/Possible Solution		Field Measurements/Component Compliance

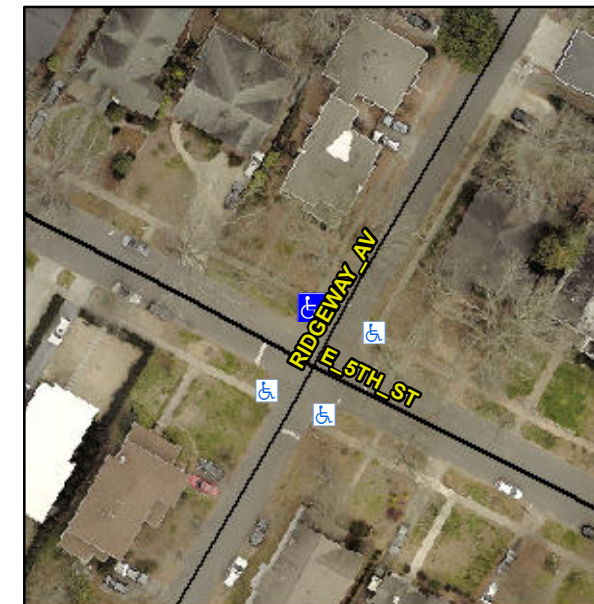
R304.5.3

Compliance	Description	Data	Compliance	Description	Data
N/A	Ramp Length (in)	59.0	Yes	Ramp Slope (%)	6.2
Yes	Ramp Width (in)	48.0	No	Ramp XSlope (%)	3.4
N/A	Flare Type LT	N/A	N/A	Flare Type RT	N/A
N/A	Flare Slope LT (%)	N/A	N/A	Flare Slope RT (%)	N/A
N/A	Flare Traversable LT?	N/A	N/A	Flare Traversable RT?	N/A
N/A	Landing Length (in)	N/A	N/A	DWS Provided?	N/A
N/A	Landing Width (in)	N/A	N/A	DWS Contrast?	N/A
N/A	Landing Slope (%)	N/A	N/A	DWS Length (in)	N/A
N/A	Landing X Slope (%)	N/A	N/A	DWS Full Width?	N/A
N/A	Landing Curb? (Y/N)	N/A	N/A	DWS Offset (in)	N/A
N/A	Shared Landing?	N/A			
N/A	Gutter Ponding?	Yes	N/A	Gutter Slope (%)	N/A
N/A	Gutter Lip Ht (in)	N/A	N/A	Gutter X Slope (%)	N/A
N/A	Painted X Walk1?	No	N/A	Painted X Walk2?	No
	X Walk 1 Direction	To SW		X Walk 2 Direction	To SE
N/A	X Walk 1 Width (in)	N/A	N/A	X Walk 2 Width (in)	N/A
	X Walk 1 Slope (%)	2.1		X Walk 2 Slope (%)	0.4
	X Walk 1 X Slope (%)	1.1		X Walk 2 X Slope (%)	1.2

N/A	Ramp inside XWalk1?	N/A	N/A	Ramp inside XWalk2?	N/A
	Road Slope (%)	0.9	N/A	Clear Space?	N/A
	Road X Slope (%)	1.5	N/A	Clear Space to XWalk (in)	N/A
N/A	Any Obstructions?	N/A	N/A	Storm Grate/Utility Hazard?	N/A
	Obstruction Type			Storm Grate/Utility Type	
		N/A			N/A
		Yes		Surface Condition? (G/P)	Good

Possible Solutions:

Remove & Replace Curb Ramp With Two New Directional Ramps or Equivalent.
