# Access Compliance Report

## Public Rights-of-Way

### (Curb Ramps)

Intersection ID: N/A	Main Street: SHARON_AMITY_RD	Cross Street: INDEPENDENCE_RD	Location: SE
ADA ID: 2042CA1D6651	Ramp Type: Perp	Initial Pass/Fail: Fail	Overall Compliance: No
Severity Score: 12.5			
Codes/Mitigation Info/Possible Solution		Field Measurements/Component Compliance

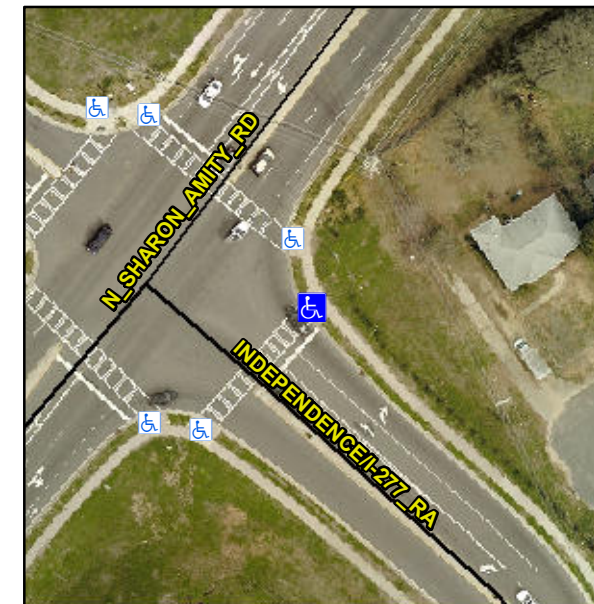
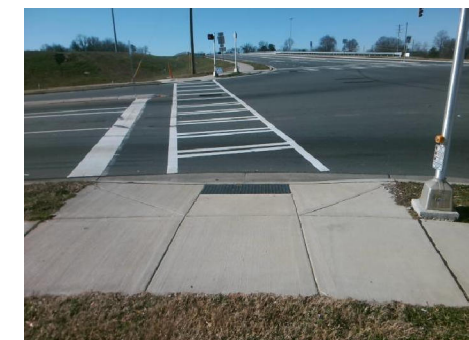
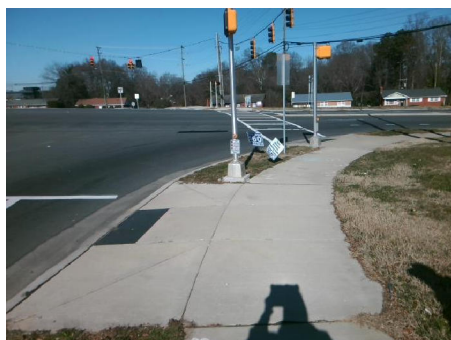
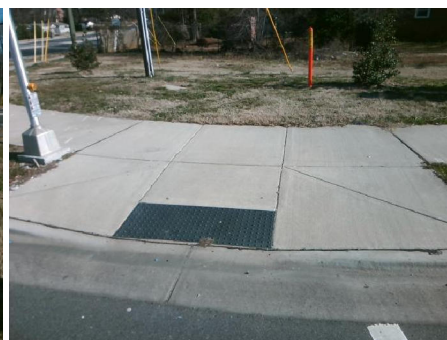
Compliance	Description	Data	Compliance	Description	Data
N/A	Ramp Length (in)	63.0	No	Ramp Slope (%)	8.6
Yes	Ramp Width (in)	59.0	Yes	Ramp XSlope (%)	0.1
N/A	Flare Type LT	N/A	N/A	Flare Type RT	N/A
N/A	Flare Slope LT (%)	N/A	N/A	Flare Slope RT (%)	N/A
N/A	Flare Traversable LT?	N/A	N/A	Flare Traversable RT?	N/A
N/A	Landing Length (in)	N/A	N/A	DWS Provided?	N/A
N/A	Landing Width (in)	N/A	N/A	DWS Contrast?	N/A
N/A	Landing Slope (%)	N/A	N/A	DWS Length (in)	N/A
N/A	Landing X Slope (%)	N/A	N/A	DWS Full Width?	N/A
N/A	Landing Curb? (Y/N)	N/A	N/A	DWS Offset (in)	N/A
N/A	Shared Landing?	N/A			
N/A	Gutter Ponding?	N/A	N/A	Gutter Slope (%)	N/A
N/A	Gutter Lip Ht (in)	N/A	N/A	Gutter X Slope (%)	N/A
N/A	Painted X Walk1?	Yes	N/A	Painted X Walk2?	N/A
	X Walk 1 Direction	To SW		X Walk 2 Direction	N/A
N/A	X Walk 1 Width (in)	111.0	N/A	X Walk 2 Width (in)	N/A
	X Walk 1 Slope (%)	6.0		X Walk 2 Slope (%)	N/A
	X Walk 1 X Slope (%)	4.0		X Walk 2 X Slope (%)	N/A

N/A	Ramp inside XWalk1?	Yes	N/A	Ramp inside XWalk2?	N/A
	Road Slope (%)	N/A	N/A	Clear Space?	N/A
	Road X Slope (%)	N/A	N/A	Clear Space to XWalk (in)	N/A
N/A	Any Obstructions?	N/A	N/A	Storm Grate/Utility Hazard?	N/A
	Obstruction Type			Storm Grate/Utility Type	
		N/A			N/A
		Yes		Surface Condition? (G/P)	Good

**Remove & Replace Entire Ramp.**

**R304.2.2**

**\$ 1850.00**
