Access Compliance Report

Public Rights-of-Way

(Curb Ramps)

Intersection ID: 10019311	Main Street: ABERDEEN_ST	Cross Street: N/A	Location: S
ADA ID: 2046E1CD29C9	Ramp Type: BlendTrans1	Initial Pass/Fail: Fail	Overall Compliance: No
Codes/Mitigation Info/Possible Solution		Field Measurements/Component Compliance	
Severity Score: 12.5

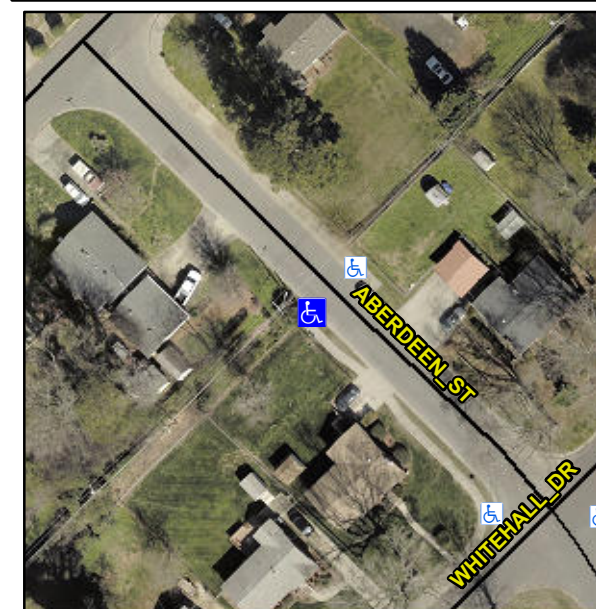
Not Found, R304.5.3

Compliance	Description	Data	Compliance	Description	Data
N/A	Ramp Length (in)	47.0	Yes	BlendTrans Slope (%)	4.0
Yes	Ramp Width (in)	48.0	No	BlendTrans XSlope (%)	5.2
N/A	Flare Type LT	N/A	N/A	Flare Type RT	N/A
N/A	Flare Slope LT (%)	N/A	N/A	Flare Slope RT (%)	N/A
N/A	Flare Traversable LT?	N/A	N/A	Flare Traversable RT?	N/A
N/A	Landing Length (in)	N/A	N/A	DWS Provided?	N/A
N/A	Landing Width (in)	N/A	N/A	DWS Contrast?	N/A
N/A	Landing Slope (%)	N/A	N/A	DWS Length (in)	N/A
N/A	Landing X Slope (%)	N/A	N/A	DWS Full Width?	N/A
N/A	Landing Curb? (Y/N)	N/A	N/A	DWS Offset (in)	N/A
N/A	Shared Landing?	N/A			
N/A	Gutter Ponding?	N/A	N/A	Gutter Slope (%)	N/A
N/A	Gutter Lip Ht (in)	N/A	N/A	Gutter X Slope (%)	N/A
N/A	Painted X Walk1?	No	N/A	Painted X Walk2?	N/A
	X Walk 1 Direction	To NE		X Walk 2 Direction	N/A
	X Walk 1 Width (in)	N/A		X Walk 2 Width (in)	N/A
	X Walk 1 Slope (%)	6.8		X Walk 2 Slope (%)	N/A
	X Walk 1 X Slope (%)	4.3		X Walk 2 X Slope (%)	N/A

N/A	Ramp inside XWalk1?	N/A	N/A	Ramp inside XWalk2?	N/A
	Road Slope (%)	4.3		Clear Space?	N/A
	Road X Slope (%)	6.8	N/A	Clear Space to XWalk (in)	N/A
N/A	Any Obstructions?	N/A	N/A	Storm Grate/Utility Hazard?	N/A
	Obstruction Type			Storm Grate/Utility Type	
		N/A			N/A
			Yes	Surface Condition? (G/P)	Good
			No	Curb Slope (%)	9.9

Remove & Replace Curb Ramp With Two New Directional Ramps or Equivalent.
