Access Compliance Report

Public Rights-of-Way

(Curb Ramps)

Intersection ID: 44310	Main Street: LINDA_VISTA_LN	Cross Street: KIEV_DR	Location: NE
ADA ID: 204C05BBCF29	Ramp Type: Perp	Initial Pass/Fail: Pass	Overall Compliance: No
Severity Score: 5			
Codes/Mitigation Info/Possible Solution		Field Measurements/Component Compliance

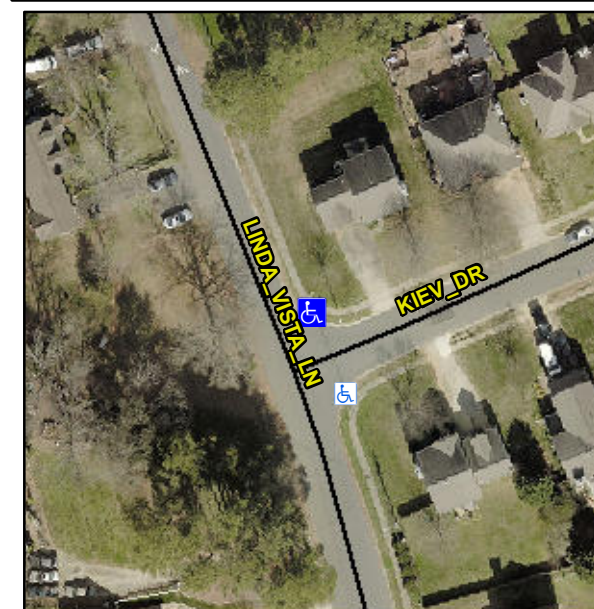
**Not Found, R304.2.1, R305.2,
R304.5.4**

Compliance	Description	Data	Compliance	Description	Data
N/A	Ramp Length (in)	47.0	Yes	Ramp Slope (%)	6.3
Yes	Ramp Width (in)	48.0	Yes	Ramp XSlope (%)	0.7
N/A	Flare Type LT	Sloped	N/A	Flare Type RT	N/A
N/A	Flare Slope LT (%)	3.5	N/A	Flare Slope RT (%)	0.5
N/A	Flare Traversable LT?	No	N/A	Flare Traversable RT?	No
No	Landing Length (in)	47.0	Yes	DWS Provided?	Yes
Yes	Landing Width (in)	66.0	Yes	DWS Contrast?	Yes
Yes	Landing Slope (%)	1.5	Yes	DWS Length (in)	24.5
Yes	Landing X Slope (%)	0.9	Yes	DWS Full Width?	Yes
N/A	Landing Curb? (Y/N)	No	No	DWS Offset (in)	8.0
N/A	Shared Landing?	No			
Yes	Gutter Ponding?	No	No	Gutter Slope (%)	7.8
Yes	Gutter Lip Ht (in)	0.0	Yes	Gutter X Slope (%)	0.5
N/A	Painted X Walk1?	No	N/A	Painted X Walk2?	N/A
	X Walk 1 Direction	To S		X Walk 2 Direction	N/A
N/A	X Walk 1 Width (in)	N/A	N/A	X Walk 2 Width (in)	N/A
	X Walk 1 Slope (%)	0.5		X Walk 2 Slope (%)	N/A
	X Walk 1 X Slope (%)	2.8		X Walk 2 X Slope (%)	N/A

N/A	Ramp inside XWalk1?	N/A	N/A	Ramp inside XWalk2?	N/A
	Road Slope (%)	N/A	N/A	Clear Space?	Yes
	Road X Slope (%)	N/A	N/A	Clear Space to XWalk (in)	N/A
Yes	Any Obstructions?	No	Yes	Storm Grate/Utility Hazard?	No
	Obstruction Type			Storm Grate/Utility Type	
			N/A		N/A
			Yes	Surface Condition? (G/P)	Good

**Remove & Replace Entire Ramp.
Remove & Replace Gutter.**
