Access Compliance Report

Public Rights-of-Way

(Curb Ramps)

Intersection ID: N/A	Main Street: E_TRADE_ST	Cross Street: S_BREVARD_ST	Location: E
ADA ID: 2050DB126FA4	Ramp Type: Perp	Initial Pass/Fail: Pass	Overall Compliance: No
Severity Score: 5.25			
Codes/Mitigation Info/Possible Solution		Field Measurements/Component Compliance

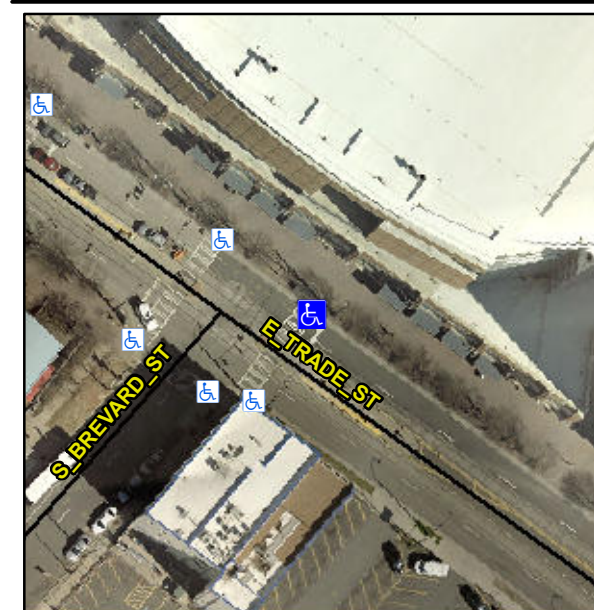
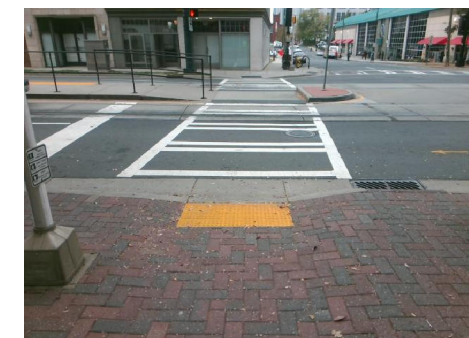
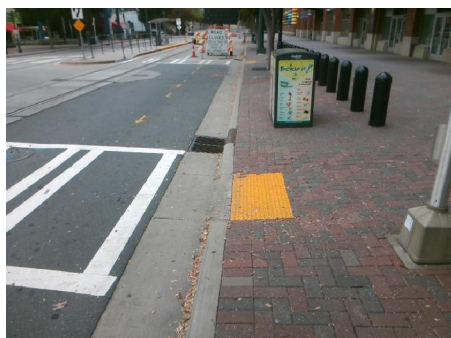
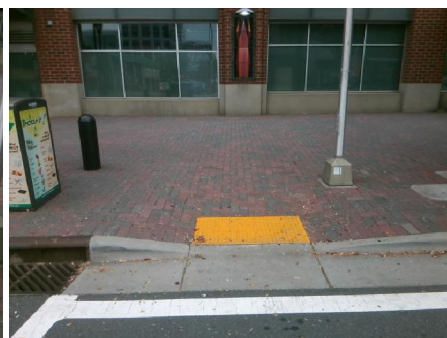
Compliance	Description	Data	Compliance	Description	Data
N/A	Ramp Length (in)	94.0	Yes	Ramp Slope (%)	8.0
Yes	Ramp Width (in)	48.0	No	Ramp XSlope (%)	3.1
N/A	Flare Type LT	Sloped	N/A	Flare Type RT	N/A
N/A	Flare Slope LT (%)	15.9	No	Flare Slope RT (%)	12.1
N/A	Flare Traversable LT?	Yes	N/A	Flare Traversable RT?	Yes
Yes	Landing Length (in)	48.0	Yes	DWS Provided?	Yes
Yes	Landing Width (in)	48.0	Yes	DWS Contrast?	Yes
No	Landing Slope (%)	2.5	Yes	DWS Length (in)	24.0
No	Landing X Slope (%)	2.1	Yes	DWS Full Width?	Yes
N/A	Landing Curb? (Y/N)	No	Yes	DWS Offset (in)	0.0
N/A	Shared Landing?	No			
Yes	Gutter Ponding?	No	Yes	Gutter Slope (%)	3.5
Yes	Gutter Lip Ht (in)	0.0	Yes	Gutter X Slope (%)	1.4
N/A	Painted X Walk1?	Yes	N/A	Painted X Walk2?	N/A
	X Walk 1 Direction	To SW		X Walk 2 Direction	N/A
N/A	X Walk 1 Width (in)	114.5	N/A	X Walk 2 Width (in)	N/A
	X Walk 1 Slope (%)	2.1		X Walk 2 Slope (%)	N/A
	X Walk 1 X Slope (%)	1.7		X Walk 2 X Slope (%)	N/A

Yes	Ramp inside XWalk1?	Yes	N/A	Ramp inside XWalk2?	N/A
	Road Slope (%)	N/A	N/A	Clear Space?	Yes
	Road X Slope (%)	N/A	N/A	Clear Space to XWalk (in)	N/A
Yes	Any Obstructions?	No	Yes	Storm Grate/Utility Hazard?	No
	Obstruction Type			Storm Grate/Utility Type	
		N/A			N/A
			Yes	Surface Condition? (G/P)	Good

Possible Solutions:

Remove & Replace Entire Ramp.

R304.5.3, R304.2.2-Perp, R304.3.2-Para, R304.2.3

Total Cost: \$ 1850.00
