## Access Compliance Report Public Rights-of-Way (Curb Ramps)

Intersection ID: 27212Main Street: FORBES\_DRCross Street: SIKES\_PLLocation:NWADA ID: 2051C9C12D06Ramp Type: PerpInitial Pass/Fail: FailOverall Compliance: NoSeverity Score: 12.5

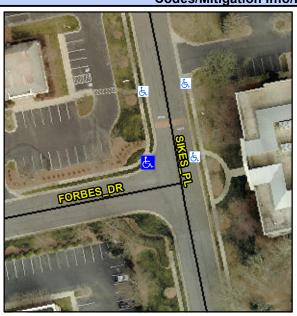
Comp	liance Description	Data	Comp	liance	Description	Data
N/A	Ramp Length (in)	49.0	No	Ram	Slope (%)	9.1
Yes	Ramp Width (in)	54.0	Yes	Ram	XSlope (%)	0.4
N/A	Flare Type LT	N/A	N/A	Flare	Type RT	N/A
N/A	Flare Slope LT (%)	N/A	N/A	Flare	Slope RT (%)	N/A
N/A	Flare Traversable LT?	N/A	N/A	Flare	Traversable RT?	N/A
N/A	Landing Length (in)	N/A	N/A	DWS	Provided?	N/A
N/A	Landing Width (in)	N/A	N/A	DWS	Contrast?	N/A
N/A	Landing Slope (%)	N/A	N/A	DWS	Length (in)	N/A
N/A	Landing X Slope (%)	N/A	N/A	DWS	Full Width?	N/A
N/A	Landing Curb? (Y/N)	N/A	N/A	DWS	Offset (in)	N/A
N/A	Shared Landing?	N/A				
N/A	Gutter Ponding?	N/A	N/A	Gutte	er Slope (%)	N/A
N/A	Gutter Lip Ht (in)	N/A	N/A	Gutte	er X Slope (%)	N/A
N/A	Painted X Walk1?	No	N/A	Paint	ed X Walk2?	N/A
	X Walk 1 Direction	То Е		X Wa	lk 2 Direction	N/A
N/A	X Walk 1 Width (in)	N/A	N/A	X Wa	lk 2 Width (in)	N/A
	X Walk 1 Slope (%)	4.3		X Wa	lk 2 Slope (%)	N/A
	X Walk 1 X Slope (%)	0.2		X Wa	lk 2 X Slope (%)	N/A

N/A	Ramp inside XWalk1?	N/A	N/A	Ram	o inside XWalk2?	N/A
	Road Slope (%)	N/A	N/A	Clear	Space?	N/A
	Road X Slope (%)	N/A	N/A	Clear	Space to XWalk (in)	N/A
N/A	Any Obstructions?	N/A	N/A	Storn	n Grate/Utility Hazard?	N/A
	Obstruction Type			Storn	n Grate/Utility Type	
		N/A				N/A
			Yes	Surfa	ce Condition? (G/P)	Good
May 1

rossible solution	
Possible Solutions:	Comp
Remove & Replace Entire Ramp.	N/A
	Yes
	N/A
	N/A
	N/A
	N/A
Surveyor Notes:	N/A
N/A	N/A
	N/A
	N/A
	N/A
PROW/ADA:	N/A
Not Found, R304.2.2	N/A
	N/A
	N/A
	N/A
