Access Compliance Report

Public Rights-of-Way

(Curb Ramps)

Intersection ID: 14369	Main Street: GREENWAY_AV	Cross Street: RIDGEWAY_AV	Location: E
ADA ID: 205A27A00A24	Ramp Type: BlendTrans2	Initial Pass/Fail: Fail	Overall Compliance: No
Codes/Mitigation Info/Possible Solution		Field Measurements/Component Compliance	
Severity Score: 1.25

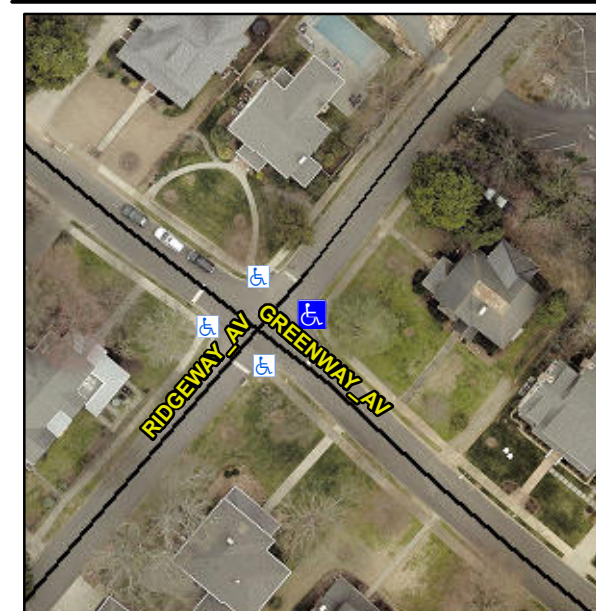
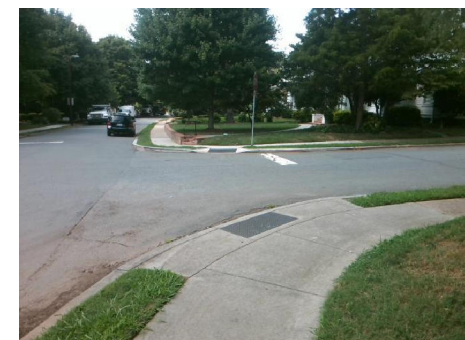
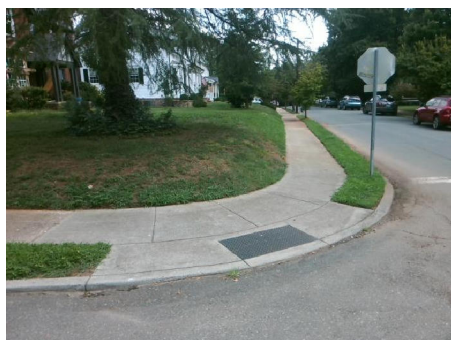
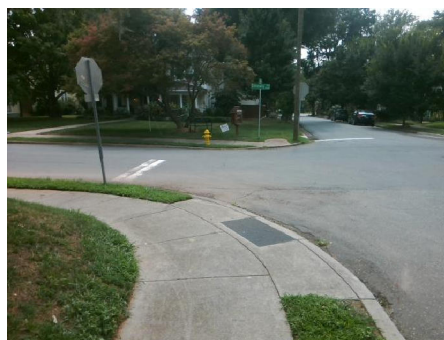
CURB LIP 0.5, ASP LIP 1.0

Not Found, R304.5.3

Compliance	Description	Data	Compliance	Description	Data
N/A	Ramp Length (in)	87.0	Yes	BlendTrans Slope (%)	4.6
Yes	Ramp Width (in)	48.0	No	BlendTrans XSlope (%)	3.4
N/A	Flare Type LT	N/A	N/A	Flare Type RT	N/A
N/A	Flare Slope LT (%)	N/A	N/A	Flare Slope RT (%)	N/A
N/A	Flare Traversable LT?	N/A	N/A	Flare Traversable RT?	N/A
N/A	Landing Length (in)	N/A	N/A	DWS Provided?	N/A
N/A	Landing Width (in)	N/A	N/A	DWS Contrast?	N/A
N/A	Landing Slope (%)	N/A	N/A	DWS Length (in)	N/A
N/A	Landing X Slope (%)	N/A	N/A	DWS Full Width?	N/A
N/A	Landing Curb? (Y/N)	N/A	N/A	DWS Offset (in)	N/A
N/A	Shared Landing?	N/A			
N/A	Gutter Ponding?	N/A	N/A	Gutter Slope (%)	N/A
N/A	Gutter Lip Ht (in)	N/A	N/A	Gutter X Slope (%)	N/A
N/A	Painted X Walk1?	No	N/A	Painted X Walk2?	No
	X Walk 1 Direction	To NW		X Walk 2 Direction	To SW
	X Walk 1 Width (in)	N/A		X Walk 2 Width (in)	N/A
	X Walk 1 Slope (%)	3.4		X Walk 2 Slope (%)	1.3
	X Walk 1 X Slope (%)	3.0		X Walk 2 X Slope (%)	1.5

N/A	Ramp inside XWalk1?	N/A	N/A	Ramp inside XWalk2?	N/A
	Road Slope (%)	1.8		Clear Space?	N/A
	Road X Slope (%)	0.4	N/A	Clear Space to XWalk (in)	N/A
N/A	Any Obstructions?	N/A	N/A	Storm Grate/Utility Hazard?	N/A
	Obstruction Type			Storm Grate/Utility Type	
		N/A			N/A
			Yes	Surface Condition? (G/P)	Good
			No	Curb Slope (%)	5.2

Possible Solutions:

Remove & Replace Curb Ramp With Two New Directional Ramps or Equivalent.
