Intersection ID: 29959	Main Street: STATESVILLE_RD	Cross Street: SMITH_CORNERS_BV	Location:	NW
ADA ID: 205AB6719628	Ramp Type: Perp	Initial Pass/Fail: Fail	Overall Compliance: No	Severity Score: 22.5

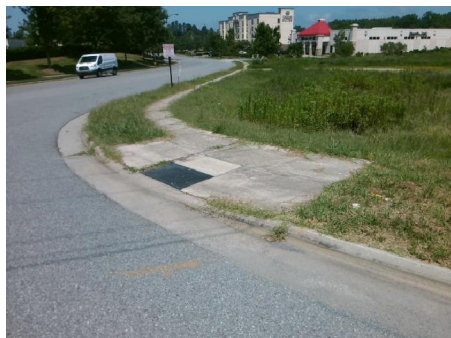
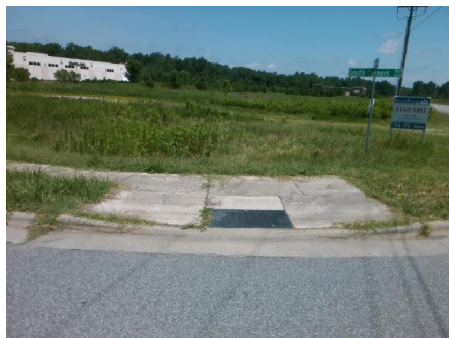
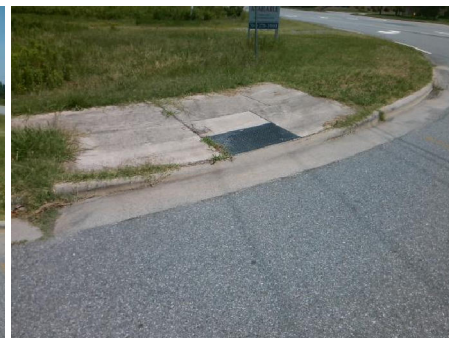
**R304.5.1, R304.2.2, R304.5.3**

Compliance	Description	Data	Compliance	Description	Data
N/A	Ramp Length (in)	47.5	No	Ramp Slope (%)	11.6
No	Ramp Width (in)	47.5	No	Ramp XSlope (%)	4.7
N/A	Flare Type LT	N/A	N/A	Flare Type RT	N/A
N/A	Flare Slope LT (%)	N/A	N/A	Flare Slope RT (%)	N/A
N/A	Flare Traversable LT?	N/A	N/A	Flare Traversable RT?	N/A
N/A	Landing Length (in)	N/A	N/A	DWS Provided?	N/A
N/A	Landing Width (in)	N/A	N/A	DWS Contrast?	N/A
N/A	Landing Slope (%)	N/A	N/A	DWS Length (in)	N/A
N/A	Landing X Slope (%)	N/A	N/A	DWS Full Width?	N/A
N/A	Landing Curb? (Y/N)	N/A	N/A	DWS Offset (in)	N/A
N/A	Shared Landing?	N/A			
N/A	Gutter Ponding?	N/A	N/A	Gutter Slope (%)	N/A
N/A	Gutter Lip Ht (in)	N/A	N/A	Gutter X Slope (%)	N/A
N/A	Painted X Walk1?	No	N/A	Painted X Walk2?	N/A
	X Walk 1 Direction	To S		X Walk 2 Direction	N/A
N/A	X Walk 1 Width (in)	N/A	N/A	X Walk 2 Width (in)	N/A
	X Walk 1 Slope (%)	7.0		X Walk 2 Slope (%)	N/A
	X Walk 1 X Slope (%)	2.3		X Walk 2 X Slope (%)	N/A

N/A	Ramp inside XWalk1?	N/A	N/A	Ramp inside XWalk2?	N/A
	Road Slope (%)	N/A	N/A	Clear Space?	N/A
	Road X Slope (%)	N/A	N/A	Clear Space to XWalk (in)	N/A
N/A	Any Obstructions?	N/A	N/A	Storm Grate/Utility Hazard?	N/A
	Obstruction Type			Storm Grate/Utility Type	
		N/A			N/A
			Yes	Surface Condition? (G/P)	Good

### Remove & Replace Entire Ramp.
