Access Compliance Report

Public Rights-of-Way

(Curb Ramps)

Intersection ID: 16523	Main Street: WALKER_RD	Cross Street: MCALWAY_RD	Location: SW
ADA ID: 205C23EB5D28	Ramp Type: Perp	Initial Pass/Fail: Fail	Overall Compliance: No
Severity Score: 21.25			
Codes/Mitigation Info/Possible Solution		Field Measurements/Component Compliance

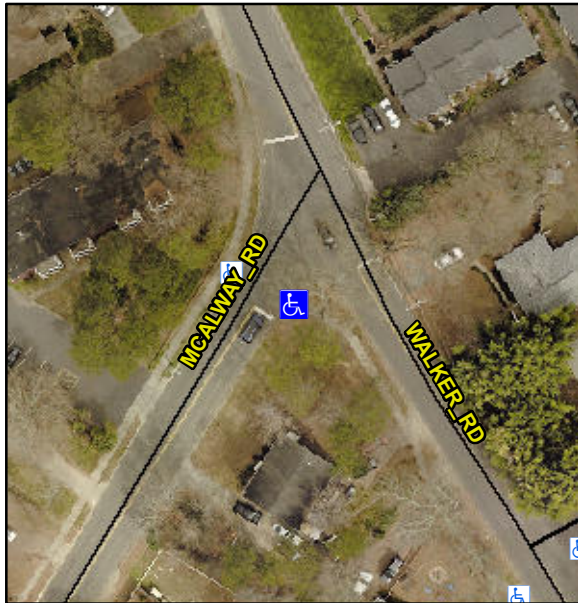
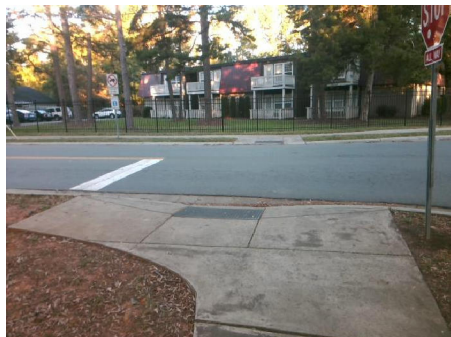
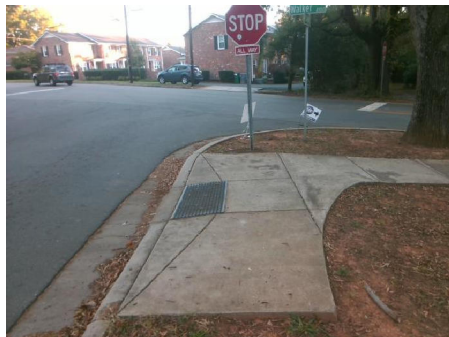
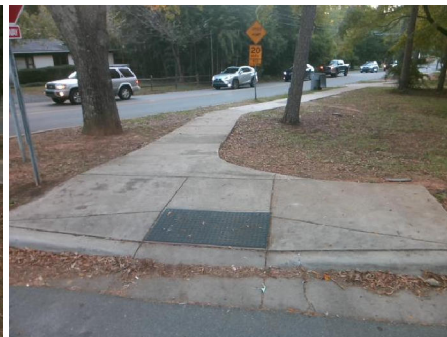
Not Found, R304.5.1, R304.2.2

Compliance	Description	Data	Compliance	Description	Data
N/A	Ramp Length (in)	65.0	No	Ramp Slope (%)	9.4
No	Ramp Width (in)	47.5	Yes	Ramp XSlope (%)	1.4
N/A	Flare Type LT	N/A	N/A	Flare Type RT	N/A
N/A	Flare Slope LT (%)	N/A	N/A	Flare Slope RT (%)	N/A
N/A	Flare Traversable LT?	N/A	N/A	Flare Traversable RT?	N/A
N/A	Landing Length (in)	N/A	N/A	DWS Provided?	N/A
N/A	Landing Width (in)	N/A	N/A	DWS Contrast?	N/A
N/A	Landing Slope (%)	N/A	N/A	DWS Length (in)	N/A
N/A	Landing X Slope (%)	N/A	N/A	DWS Full Width?	N/A
N/A	Landing Curb? (Y/N)	N/A	N/A	DWS Offset (in)	N/A
N/A	Shared Landing?	N/A			
N/A	Gutter Ponding?	N/A	N/A	Gutter Slope (%)	N/A
N/A	Gutter Lip Ht (in)	N/A	N/A	Gutter X Slope (%)	N/A
N/A	Painted X Walk1?	No	N/A	Painted X Walk2?	N/A
	X Walk 1 Direction	To NW		X Walk 2 Direction	N/A
N/A	X Walk 1 Width (in)	N/A	N/A	X Walk 2 Width (in)	N/A
	X Walk 1 Slope (%)	5.5		X Walk 2 Slope (%)	N/A
	X Walk 1 X Slope (%)	0.0		X Walk 2 X Slope (%)	N/A

N/A	Ramp inside XWalk1?	N/A	N/A	Ramp inside XWalk2?	N/A
	Road Slope (%)	N/A	N/A	Clear Space?	N/A
	Road X Slope (%)	N/A	N/A	Clear Space to XWalk (in)	N/A
N/A	Any Obstructions?	N/A	N/A	Storm Grate/Utility Hazard?	N/A
	Obstruction Type			Storm Grate/Utility Type	
		N/A			N/A
			Yes	Surface Condition? (G/P)	Good

Remove & Replace Entire Ramp.

Total Cost: \$ 1850.00
