# Access Compliance Report

## Public Rights-of-Way

### (Curb Ramps)

| Intersection ID: 52448 | Main Street: WOODWARD_AV | Cross Street: DOUBLE_OAKS_RD | Location: NW |

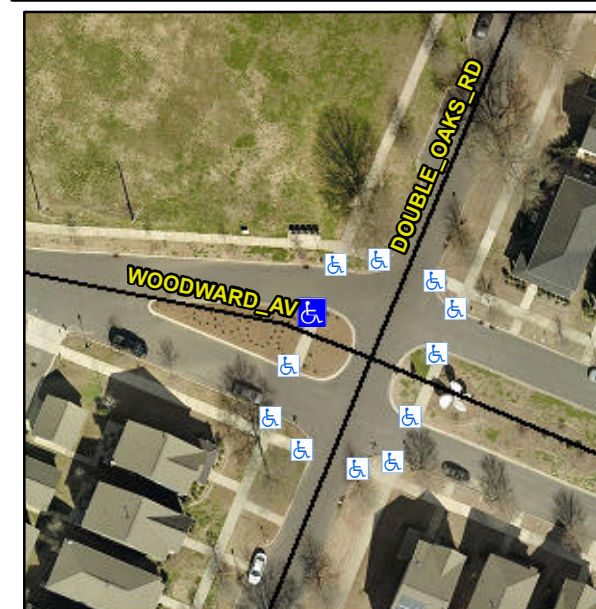
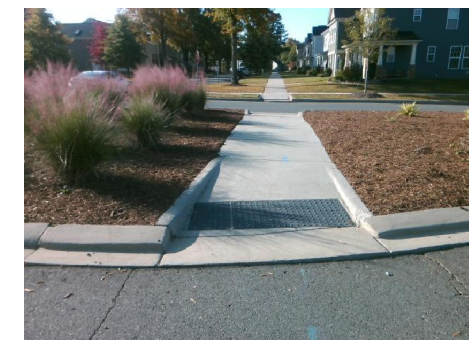
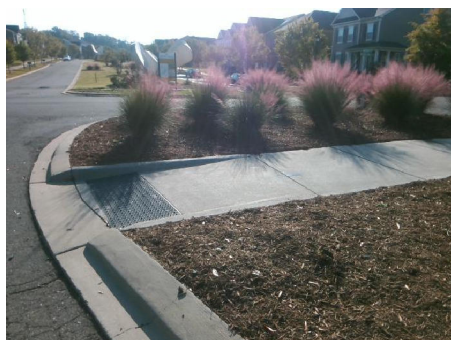
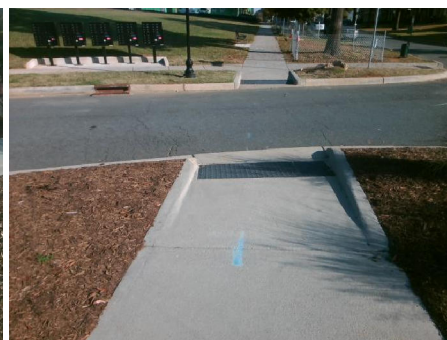
| ADA ID: 2065FBABBBE6 | Ramp Type: Directional1 | Initial Pass/Fail: Fail | Overall Compliance: No |

**LOCATED ON MEDIAN**

**R304.2.2**

| Compliance | Description | Data | Compliance | Description | Data |
|---|---|---|---|---|---|
| No | Ramp Slope (%) | 8.4 | N/A | Grade Break XSlope (%) | 0.0 |

**Remove & Replace Entire Ramp.**
