Access Compliance Report Public Rights-of-Way (Curb Ramps)

Intersection ID: 11940 Main Street: BELVEDERE AV **Cross Street: HAWTHORNE LN** Location: ADA ID: 206B0EE63527 Ramp Type: PerpDiag Initial Pass/Fail: Fail **Overall Compliance: No** Severity Score: 21.25

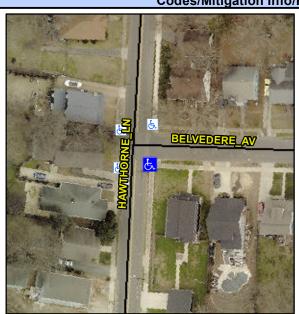
Field Measurements/Component Compliance							
	Compl	Compliance Description		Compliance		Description	Data
	N/A	Ramp Length (in)	77.0	Yes	Ramp	Slope (%)	7.5
	No	Ramp Width (in)	46.5	No	Ramp	XSlope (%)	5.2
	N/A	Flare Type LT	N/A	N/A	Flare	Type RT	N/A
	N/A	Flare Slope LT (%)	N/A	N/A	Flare	Slope RT (%)	N/A
	N/A	Flare Traversable LT?	N/A	N/A	Flare	Traversable RT?	N/A
	N/A	Landing Length (in)	N/A	N/A	DWS	Provided?	N/A
	N/A	Landing Width (in)	N/A	N/A	DWS	Contrast?	N/A
	N/A	Landing Slope (%)	N/A	N/A	DWS	Length (in)	N/A
	N/A	Landing X Slope (%)	N/A	N/A	DWS	Full Width?	N/A
	N/A	Landing Curb? (Y/N)	N/A	N/A	DWS	Offset (in)	N/A
	N/A	Shared Landing?	N/A				
	N/A	Gutter Ponding?	N/A	N/A	Gutte	er Slope (%)	N/A
	N/A	Gutter Lip Ht (in)	N/A	N/A	Gutte	er X Slope (%)	N/A
	N/A	Painted X Walk1?	No	N/A	Paint	ed X Walk2?	No
		X Walk 1 Direction	To N		X Wa	lk 2 Direction	To W
	N/A	X Walk 1 Width (in)	N/A	N/A	X Wa	lk 2 Width (in)	N/A

X Walk 1 Slope (%)	6.5		X Wa	lk 2 Slope (%)	2.0
		X Walk 1 X Slope (%)	0.1		X Wa	lk 2 X Slope (%)	5.9
	N/A	Ramp inside XWalk1?	N/A	N/A	Ram	o inside XWalk2?	N/A
		Road Slope (%)	3.7	N/A	Clear	Space?	N/A
		Road X Slope (%)	5.4	N/A	Clear	Space to XWalk (in)	N/A
	N/A	Any Obstructions?	N/A	N/A	Storn	n Grate/Utility Hazard?	N/A
		Obstruction Type			Storn	n Grate/Utility Type	
			N/A				N/A
				Yes	Surfa	ce Condition? (G/P)	Good
	Mit I Lake	# /9 Min 200 min 100 m

Possible Solutions: Remove & Replace Curb Ramp With **Two New Directional Ramps or** Equivalent. Surveyor Notes: N/A PROW/ADA: Not Found, R304.5.1, R304.5.3
