## **Access Compliance Report Public Rights-of-Way** (Curb Ramps)

Intersection ID: 14202 Main Street: E 3RD ST **Cross Street: LILLINGTON AV** Location: W

Initial Pass/Fail: Fail **Overall Compliance: No** ADA ID: 20754A72199D Ramp Type: PerpDiag Severity Score: 18.75

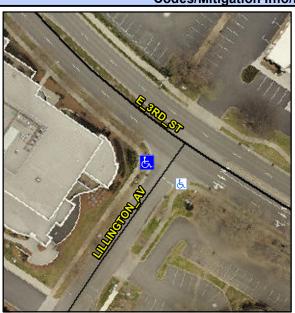
**LILLINGTON AV** Street 1 Name Stop Condition-Street 2 StopSign E 3RD ST Street 2 Name Stop Condition-Street 1

Remove & Replace Curb Ramp With Two New Directional Ramps or Equivalent.

N/A			N/A
			N/A
			N/A
			N/A
PROW/ADA:			N/A
R304.5.1, R304.5.3			N/A
			N/A
			N/A
			N/A
F-1-1 O1	<b>r</b>	3200.00	N/A
Total Cost:	\$	3200.00
