# Access Compliance Report

## Public Rights-of-Way

### (Curb Ramps)

Intersection ID: 42920	Main Street: HIGHFIELD_CT	Cross Street: RUSTIC_VIEW_CT	Location: S
ADA ID: 2095143327EF	Ramp Type: PerpDiag	Initial Pass/Fail: Fail	Overall Compliance: No
		Severity Score: 25

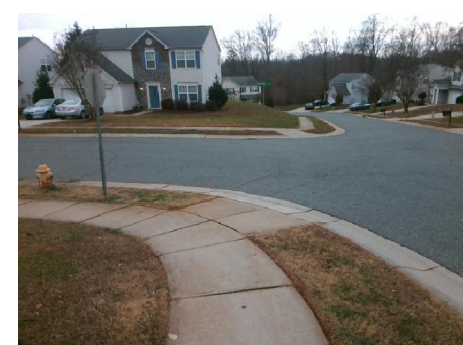
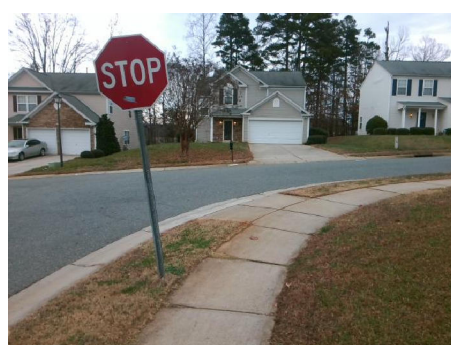
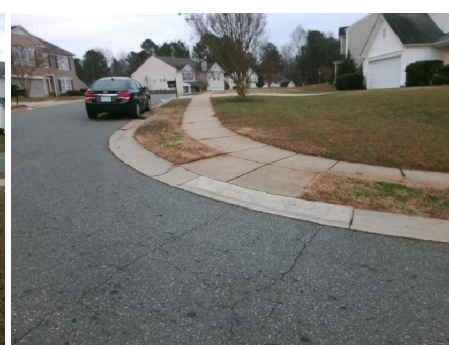
**Not Found, R304.5.3**

Compliance	Description	Data	Compliance	Description	Data
N/A	Ramp Length (in)	45.0	Yes	Ramp Slope (%)	7.7
Yes	Ramp Width (in)	48.0	No	Ramp XSlope (%)	8.8
N/A	Flare Type LT	N/A	N/A	Flare Type RT	N/A
N/A	Flare Slope LT (%)	N/A	N/A	Flare Slope RT (%)	N/A
N/A	Flare Traversable LT?	N/A	N/A	Flare Traversable RT?	N/A
N/A	Landing Length (in)	N/A	N/A	DWS Provided?	N/A
N/A	Landing Width (in)	N/A	N/A	DWS Contrast?	N/A
N/A	Landing Slope (%)	N/A	N/A	DWS Length (in)	N/A
N/A	Landing X Slope (%)	N/A	N/A	DWS Full Width?	N/A
N/A	Landing Curb? (Y/N)	N/A	N/A	DWS Offset (in)	N/A
N/A	Shared Landing?	N/A			
N/A	Gutter Ponding?	N/A	N/A	Gutter Slope (%)	N/A
N/A	Gutter Lip Ht (in)	N/A	N/A	Gutter X Slope (%)	N/A
N/A	Painted X Walk1?	No	N/A	Painted X Walk2?	No
	X Walk 1 Direction	To NE		X Walk 2 Direction	To NW
N/A	X Walk 1 Width (in)	N/A	N/A	X Walk 2 Width (in)	N/A
	X Walk 1 Slope (%)	2.9		X Walk 2 Slope (%)	4.7
	X Walk 1 X Slope (%)	8.2		X Walk 2 X Slope (%)	5.7

N/A	Ramp inside XWalk1?	N/A	N/A	Ramp inside XWalk2?	N/A
	Road Slope (%)	9.1	N/A	Clear Space?	N/A
	Road X Slope (%)	1.0	N/A	Clear Space to XWalk (in)	N/A
N/A	Any Obstructions?	N/A	N/A	Storm Grate/Utility Hazard?	N/A
	Obstruction Type			Storm Grate/Utility Type	
		N/A			N/A
		Yes		Surface Condition? (G/P)	Good

**Remove & Replace Curb Ramp With Two New Directional Ramps or Equivalent.**
