Access Compliance Report

Public Rights-of-Way

(Curb Ramps)

Intersection ID: 19313	Main Street: RANDOLPH_RD	Cross Street: SARDIS_RD	Location:	W
ADA ID: 209BDA73DDA9	Ramp Type: Perp	Initial Pass/Fail: Fail	Overall Compliance: No	Severity Score: 25
Codes/Mitigation Info/Possible Solution		Field Measurements/Component Compliance

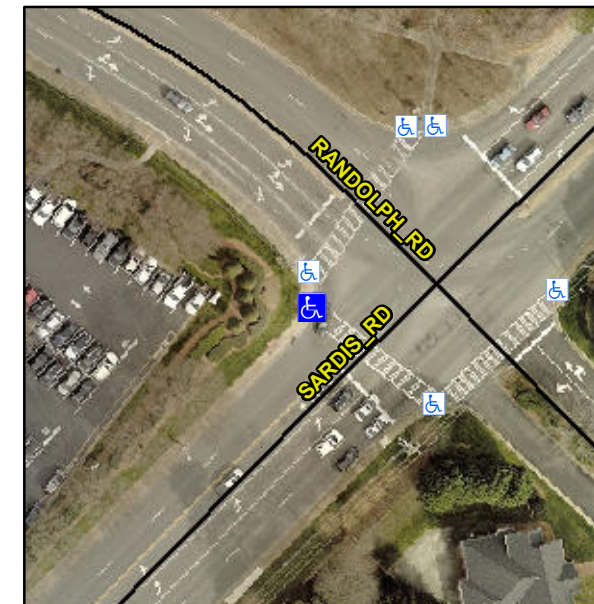
Not Found, R304.2.2, R304.5.3

Compliance	Description	Data	Compliance	Description	Data
N/A	Ramp Length (in)	65.0	No	Ramp Slope (%)	8.4
Yes	Ramp Width (in)	48.0	No	Ramp XSlope (%)	5.8
N/A	Flare Type LT	N/A	N/A	Flare Type RT	N/A
N/A	Flare Slope LT (%)	N/A	N/A	Flare Slope RT (%)	N/A
N/A	Flare Traversable LT?	N/A	N/A	Flare Traversable RT?	N/A
N/A	Landing Length (in)	N/A	N/A	DWS Provided?	N/A
N/A	Landing Width (in)	N/A	N/A	DWS Contrast?	N/A
N/A	Landing Slope (%)	N/A	N/A	DWS Length (in)	N/A
N/A	Landing X Slope (%)	N/A	N/A	DWS Full Width?	N/A
N/A	Landing Curb? (Y/N)	N/A	N/A	DWS Offset (in)	N/A
N/A	Shared Landing?	N/A			
N/A	Gutter Ponding?	N/A	N/A	Gutter Slope (%)	N/A
N/A	Gutter Lip Ht (in)	N/A	N/A	Gutter X Slope (%)	N/A
N/A	Painted X Walk1?	Yes	N/A	Painted X Walk2?	N/A
	X Walk 1 Direction	To SE		X Walk 2 Direction	N/A
N/A	X Walk 1 Width (in)	108.0	N/A	X Walk 2 Width (in)	N/A
	X Walk 1 Slope (%)	7.0		X Walk 2 Slope (%)	N/A
	X Walk 1 X Slope (%)	0.8		X Walk 2 X Slope (%)	N/A

N/A	Ramp inside XWalk1?	Yes	N/A	Ramp inside XWalk2?	N/A
	Road Slope (%)	N/A	N/A	Clear Space?	N/A
	Road X Slope (%)	N/A	N/A	Clear Space to XWalk (in)	N/A
N/A	Any Obstructions?	N/A	N/A	Storm Grate/Utility Hazard?	N/A
	Obstruction Type			Storm Grate/Utility Type	
		N/A			N/A
		Yes		Surface Condition? (G/P)	Good

Possible Solutions:

Remove & Replace Entire Ramp.
