Access Compliance Report

Public Rights-of-Way

(Curb Ramps)

Intersection ID: 12093	Main Street: MATHESON_AV	Cross Street: MECKLENBURG_AV	Location: NW
ADA ID: 209C381071C3	Ramp Type: Perp	Initial Pass/Fail: Fail	Overall Compliance: No
Codes/Mitigation Info/Possible Solution		Field Measurements/Component Compliance	
Severity Score: 10

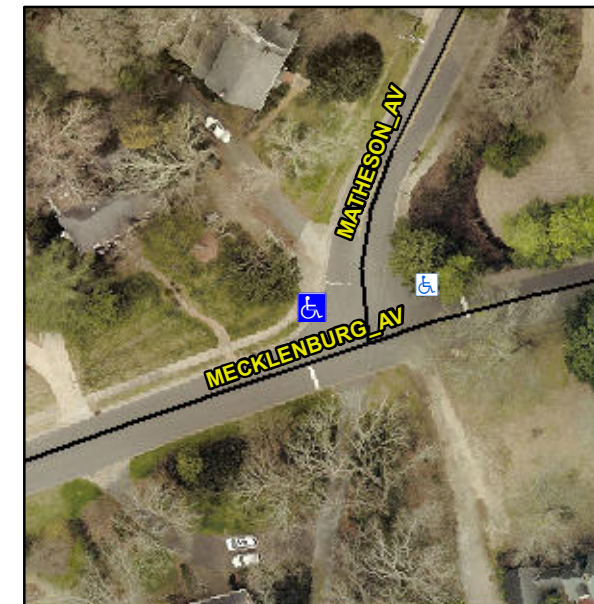
Not Found, R304.5.1, R304.5.3

Compliance	Description	Data	Compliance	Description	Data
N/A	Ramp Length (in)	48.0	Yes	Ramp Slope (%)	6.6
No	Ramp Width (in)	42.5	No	Ramp XSlope (%)	3.5
N/A	Flare Type LT	N/A	N/A	Flare Type RT	N/A
N/A	Flare Slope LT (%)	N/A	N/A	Flare Slope RT (%)	N/A
N/A	Flare Traversable LT?	N/A	N/A	Flare Traversable RT?	N/A
N/A	Landing Length (in)	N/A	N/A	DWS Provided?	N/A
N/A	Landing Width (in)	N/A	N/A	DWS Contrast?	N/A
N/A	Landing Slope (%)	N/A	N/A	DWS Length (in)	N/A
N/A	Landing X Slope (%)	N/A	N/A	DWS Full Width?	N/A
N/A	Landing Curb? (Y/N)	N/A	N/A	DWS Offset (in)	N/A
N/A	Shared Landing?	N/A			
N/A	Gutter Ponding?	N/A	N/A	Gutter Slope (%)	N/A
N/A	Gutter Lip Ht (in)	N/A	N/A	Gutter X Slope (%)	N/A
N/A	Painted X Walk1?	No	N/A	Painted X Walk2?	N/A
	X Walk 1 Direction	To E		X Walk 2 Direction	N/A
N/A	X Walk 1 Width (in)	N/A	N/A	X Walk 2 Width (in)	N/A
	X Walk 1 Slope (%)	5.3		X Walk 2 Slope (%)	N/A
	X Walk 1 X Slope (%)	0.8		X Walk 2 X Slope (%)	N/A

N/A	Ramp inside XWalk1?	N/A	N/A	Ramp inside XWalk2?	N/A
	Road Slope (%)	N/A	N/A	Clear Space?	N/A
	Road X Slope (%)	N/A	N/A	Clear Space to XWalk (in)	N/A
N/A	Any Obstructions?	N/A	N/A	Storm Grate/Utility Hazard?	N/A
	Obstruction Type			Storm Grate/Utility Type	
		N/A			N/A
			Yes	Surface Condition? (G/P)	Good

Remove & Replace Entire Ramp.

Total Cost: \$ 1850.00
