Access Compliance Report

Public Rights-of-Way (Curb Ramps)

Intersection ID: 26949	Main Street: LADY_GRACE_LN	Cross Street: SARAH_HALL_LN	Location: NE
ADA ID: 20AC8EA0AD5D	Ramp Type: Para	Initial Pass/Fail: Fail	Overall Compliance: No
Severity Score: 13.75			
Codes/Mitigation Info/Possible Solution		Field Measurements/Component Compliance

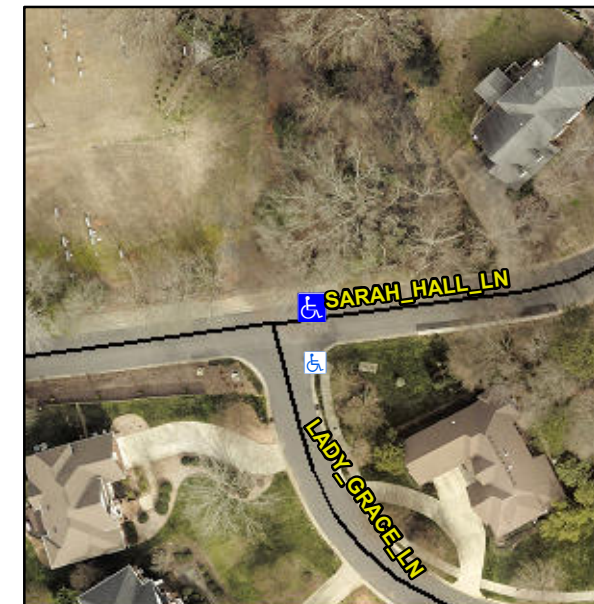
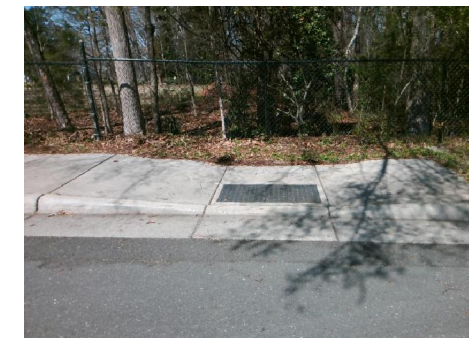
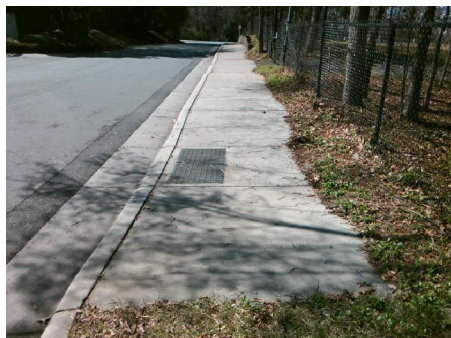
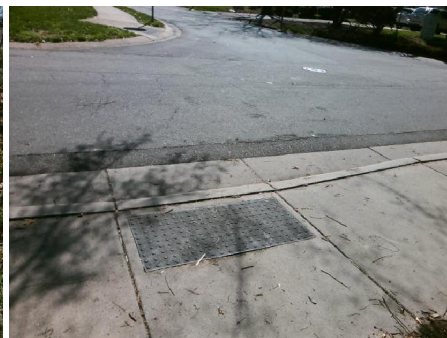
RT RP < 5%

R304.3.2, R304.5.3

Compliance	Description	Data	Compliance	Description	Data
N/A	Ramp Length LT (in)	73.0	N/A	Ramp Length RT (in)	71.0
Yes	Ramp Width LT (in)	70.0	Yes	Ramp Width RT (in)	70.0
No	Ramp Slope LT (%)	8.7	Yes	Ramp Slope RT (%)	2.4
No	Ramp XSlope LT (%)	3.3	Yes	Ramp XSlope RT (%)	2.0
N/A	Landing Length (in)	N/A	N/A	DWS Provided?	N/A
N/A	Landing Width (in)	N/A	N/A	DWS Contrast?	N/A
N/A	Landing Slope (%)	N/A	N/A	DWS Length (in)	N/A
N/A	Landing X Slope (%)	N/A	N/A	DWS Full Width?	N/A
N/A	Landing Curb? (Y/N)	N/A	N/A	DWS Offset (in)	N/A
N/A	Shared Landing?	N/A			
N/A	Gutter Ponding?	N/A	N/A	Gutter Slope (%)	N/A
N/A	Gutter Lip Ht (in)	N/A	N/A	Gutter X Slope (%)	N/A
N/A	Painted X Walk1?	No	N/A	Painted X Walk2?	N/A
	X Walk 1 Direction	To S		X Walk 2 Direction	N/A
N/A	X Walk 1 Width (in)	N/A	N/A	X Walk 2 Width (in)	N/A
	X Walk 1 Slope (%)	2.3		X Walk 2 Slope (%)	N/A
	X Walk 1 X Slope (%)	2.9		X Walk 2 X Slope (%)	N/A
N/A	Ramp inside XWalk1?	N/A	N/A	Ramp inside XWalk2?	N/A

Road Slope (%)	N/A	N/A	Clear Space?	N/A
	Road X Slope (%)	N/A	N/A	Clear Space to XWalk (in)	N/A
N/A	Any Obstructions?	N/A	N/A	Storm Grate/Utility Hazard?	N/A
	Obstruction Type			Storm Grate/Utility Type	
		N/A			N/A
			Yes	Surface Condition? (G/P)	Good
			N/A	Curb Slope (%)	20.0

Remove & Replace Entire Ramp.
