Access Compliance Report

Public Rights-of-Way

(Curb Ramps)

| Intersection ID: 42521 | Main Street: I-485_RA | Cross Street: PROVIDENCE_RD | Location: SE |

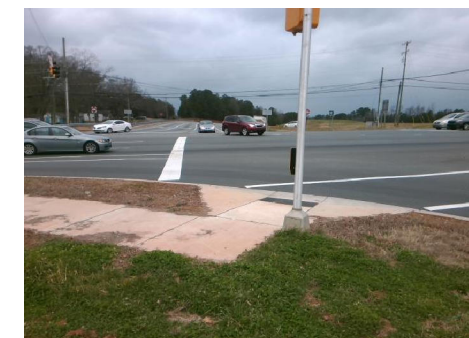
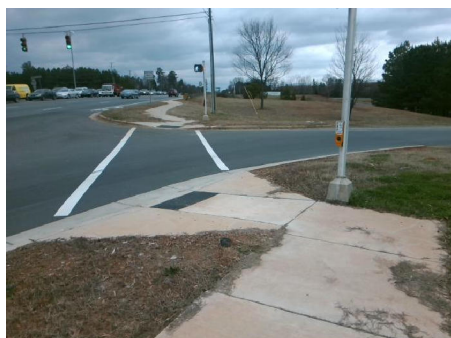
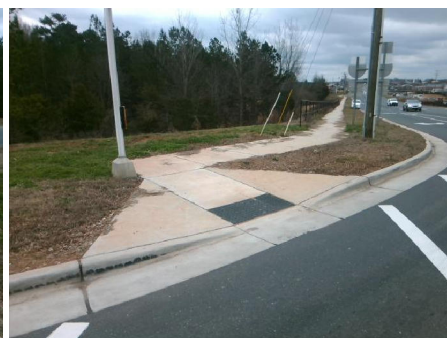
| ADA ID: 20B2C90DDB43 | Ramp Type: PerpDiag | Initial Pass/Fail: Fail | Overall Compliance: No |

R304.2.2, R304.5.3

| Compliance | Description | Data | Compliance | Description | Data |
|---|---|---|---|---|---|
| N/A | Ramp Length (in) | 96.0 | No | Ramp Slope (%) | 8.6 |
| Yes | Ramp Width (in) | 48.0 | No | Ramp XSlope (%) | 2.3 |

Remove & Replace Curb Ramp With Two New Directional Ramps or Equivalent.
