## **Access Compliance Report Public Rights-of-Way** (Curb Ramps)

Intersection ID: 10041631 Main Street: WHITEHALL PARK DR Cross Street: N/A Location: NW Initial Pass/Fail: Fail **Overall Compliance: No Severity Score:** 25 ADA ID: 20B76FF253B6 Ramp Type: PerpDiag

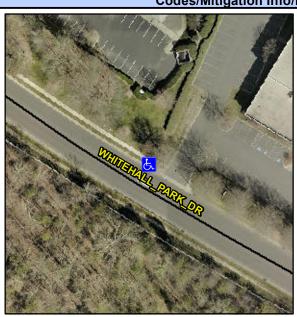
Street 1 Name WHITEHALL PARK DR Stop Condition-Street 2 None **ENTRANCE** Street 2 Name Stop Condition-Street 1 None Possible Solutions: Remove & Replace Curb Ramp With Two New Directional Ramps or Equivalent. Surveyor Notes: N/A PROW/ADA: Not Found, R304.2.2, R304.5.3

Compliance Description Data Compliance Description Data No N/A Ramp Length (in) 36.0 Ramp Slope (%) 9.6 No Ramp XSlope (%) Yes Ramp Width (in) 48.0 5.8 N/A N/A Flare Type LT N/A Flare Type RT N/A N/A N/A N/A Flare Slope RT (%) N/A Flare Slope LT (%) N/A Flare Traversable LT? N/A N/A Flare Traversable RT? N/A N/A N/A N/A **DWS Provided?** N/A Landing Length (in) N/A Landing Width (in) N/A N/A **DWS Contrast?** N/A N/A N/A Landing Slope (%) N/A DWS Length (in) N/A N/A Landing X Slope (%) N/A N/A DWS Full Width? N/A N/A Landing Curb? (Y/N) N/A N/A DWS Offset (in) N/A N/A N/A Shared Landing? N/A **Gutter Ponding?** N/A N/A Gutter Slope (%) N/A N/A Gutter Lip Ht (in) N/A N/A Gutter X Slope (%) N/A N/A Painted X Walk1? No N/A Painted X Walk2? No X Walk 1 Direction To SW X Walk 2 Direction To SE N/A N/A X Walk 1 Width (in) X Walk 2 Width (in) N/A X Walk 1 Slope (%) 3.3 X Walk 2 Slope (%) 2.2 X Walk 1 X Slope (%) 0.5 X Walk 2 X Slope (%) 4.0 N/A N/A N/A Ramp inside XWalk2? N/A Ramp inside XWalk1? Road Slope (%) 4.0 N/A Clear Space? N/A N/A Road X Slope (%) Clear Space to XWalk (in) N/A 4.3 N/A N/A N/A Any Obstructions? Storm Grate/Utility Hazard? N/A **Obstruction Type** Storm Grate/Utility Type N/A N/A Yes Surface Condition? (G/P) Good
