Access Compliance Report

Public Rights-of-Way

(Curb Ramps)

Intersection ID: 9623	Main Street: BREWTON_DR	Cross Street: PEACEFUL_WAY_DR	Location: SW
ADA ID: 20C433F5C878	Ramp Type: Perp	Initial Pass/Fail: Fail	Overall Compliance: No
			Severity Score: 33.75

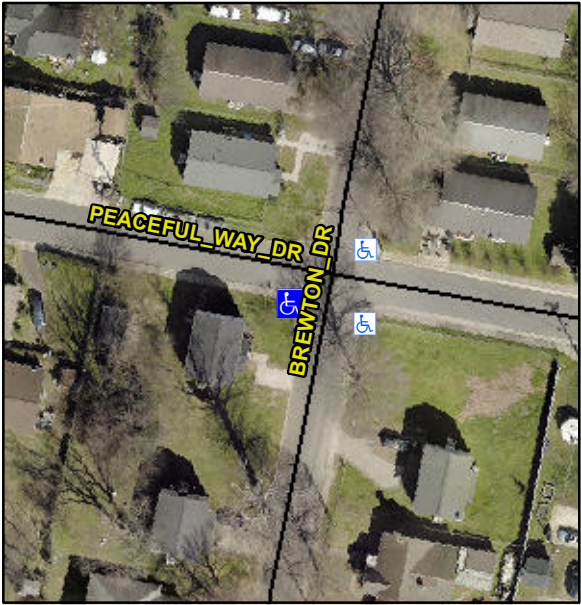
Possible Solutions:		Compliance	Description	Data
	Remove & Replace Entire Ramp.		N/A	Ramp Length (in)	66.0
			No	Ramp Width (in)	41.0
			N/A	Flare Type LT	N/A
			N/A	Flare Slope LT (%)	N/A
			N/A	Flare Traversable LT?	N/A
			N/A	Landing Length (in)	N/A
			N/A	Landing Width (in)	N/A
			N/A	Landing Slope (%)	N/A
			N/A	Landing X Slope (%)	N/A
<p>Surveyor Notes:</p> <p>N/A</p> <p>PROW/ADA:</p> <p>R304.5.1, R304.2.2</p>			N/A	Flare Type RT	N/A
			N/A	Flare Slope RT (%)	N/A
			N/A	Flare Traversable RT?	N/A
			N/A	DWS Provided?	N/A
			N/A	DWS Contrast?	N/A
			N/A	DWS Length (in)	N/A
			N/A	DWS Full Width?	N/A
			N/A	DWS Offset (in)	N/A
			N/A	Shared Landing?	N/A
			N/A	Gutter Ponding?	N/A
			N/A	Gutter Lip Ht (in)	N/A
			N/A	Painted X Walk1?	No
				X Walk 1 Direction	To E
			N/A	X Walk 1 Width (in)	N/A
				X Walk 1 Slope (%)	5.8
				X Walk 1 X Slope (%)	3.1

N/A	Ramp inside XWalk1?	N/A
				Road Slope (%)	N/A
				Road X Slope (%)	N/A
			N/A	Any Obstructions?	N/A
				Obstruction Type	
Total Cost:		\$ 1850.00			
			N/A		N/A
			Yes	Surface Condition? (G/P)	Good
