# Access Compliance Report

## Public Rights-of-Way

| Intersection ID: 53704 | Main Street: MILLSTREAM RIDGE DR | Cross Street: CHRISTENBURY RD | Location: S |
| ADA ID: 20D2A10B6ED6 | Ramp Type: Perp | Initial Pass/Fail: Pass | Overall Compliance: No |

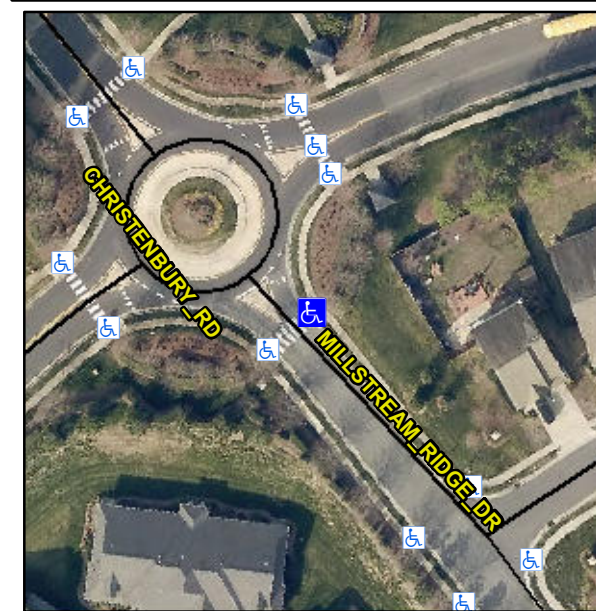
**Not Found, R304.2.1, R304.2.2-Perp,  
R304.3.2-Para, R304.5.3, R305,  
R304.5.4**

| Compliance | Description | Data | Compliance | Description | Data |
|---|---|---|---|---|---|
| No | Landing Length (in) | N/A | No | DWS Provided? | No |
| No | Landing Width (in) | N/A | N/A | DWS Contrast? | No |
| No | Landing Slope (%) | N/A | N/A | DWS Length (in) | N/A |
| No | Landing X Slope (%) | N/A | N/A | DWS Full Width? | No |
| Yes | Gutter Ponding? | No | No | Gutter Slope (%) | 5.1 |

**Remove & Replace Entire Ramp.  
Remove & Replace Gutter.**

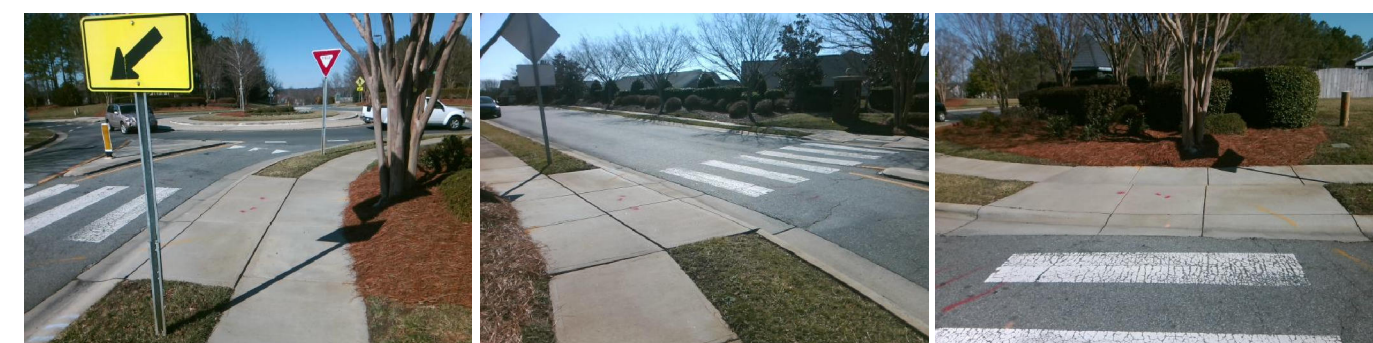
| Severity Score: 25 | | | |
