# Access Compliance Report

## Public Rights-of-Way

### (Curb Ramps)

| Intersection ID: 10035606 | Main Street: REAVENCREST_PARK_DR | Cross Street: N/A | Location: NW |

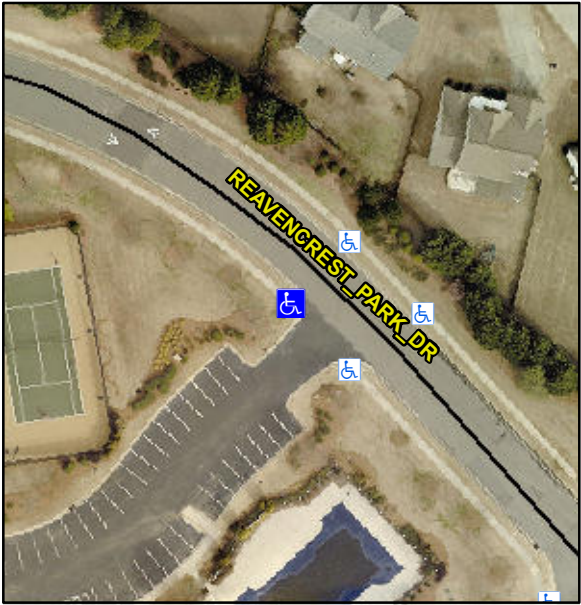
| ADA ID: 20E6BFF099BD | Ramp Type: PerpDiag | Initial Pass/Fail: Fail | Overall Compliance: No |

| Codes/Mitigation Info/Possible Solution | | | Field Measurements/Component Compliance | | | |
|---|---|---|---|---|---|---|
| | | | No | Ramp Width (in) | 32.0 | <b>Yes</b> |
| <p>Surveyor Notes:</p> <p>N/A</p> <p>PROW/ADA:</p> <p>Not Found, R304.5.1</p> | | | | | | |
| | | | | Ramp Slope (%) | 6.7 | |
| | | | | Ramp XSlope (%) | 1.3 | |

| Codes/Mitigation Info/Possible Solution | | | Field Measurements/Component Compliance | | | |
|---|---|---|---|---|---|---|
| | <b>Remove &amp; Replace Curb Ramp With Two New Directional Ramps or Equivalent.</b> | | N/A | Ramp Length (in) | 100.0 | <b>Yes</b> |
