Access Compliance Report

Public Rights-of-Way

(Curb Ramps)

Intersection ID: 50634	Main Street: BLUE_JASPER_RD	Cross Street: CORAL_ROSE_RD	Location: SW
ADA ID: 20ECE57C7BC1	Ramp Type: Perp	Initial Pass/Fail: Fail	Overall Compliance: No
		Severity Score: 12.5

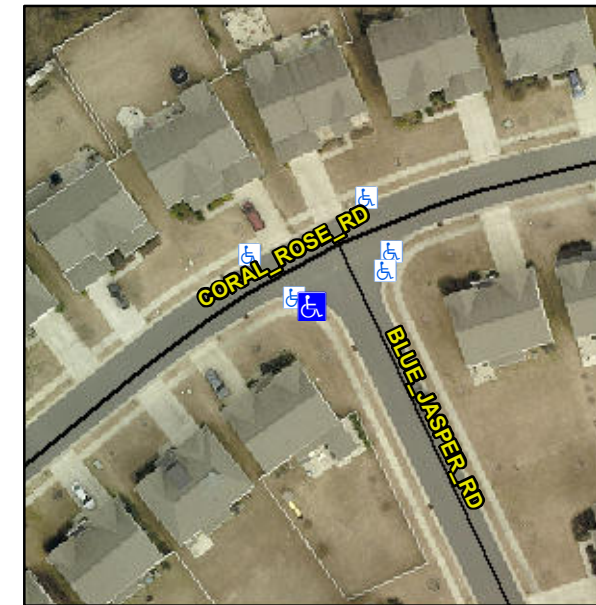
Not Found, R304.5.3

Compliance	Description	Data	Compliance	Description	Data
N/A	Ramp Length (in)	45.5	Yes	Ramp Slope (%)	7.8
Yes	Ramp Width (in)	48.0	No	Ramp XSlope (%)	6.0
N/A	Flare Type LT	N/A	N/A	Flare Type RT	N/A
N/A	Flare Slope LT (%)	N/A	N/A	Flare Slope RT (%)	N/A
N/A	Flare Traversable LT?	N/A	N/A	Flare Traversable RT?	N/A
N/A	Landing Length (in)	N/A	N/A	DWS Provided?	N/A
N/A	Landing Width (in)	N/A	N/A	DWS Contrast?	N/A
N/A	Landing Slope (%)	N/A	N/A	DWS Length (in)	N/A
N/A	Landing X Slope (%)	N/A	N/A	DWS Full Width?	N/A
N/A	Landing Curb? (Y/N)	N/A	N/A	DWS Offset (in)	N/A
N/A	Shared Landing?	N/A			
N/A	Gutter Ponding?	N/A	N/A	Gutter Slope (%)	N/A
N/A	Gutter Lip Ht (in)	N/A	N/A	Gutter X Slope (%)	N/A
N/A	Painted X Walk1?	No	N/A	Painted X Walk2?	N/A
	X Walk 1 Direction	To NE		X Walk 2 Direction	N/A
N/A	X Walk 1 Width (in)	N/A	N/A	X Walk 2 Width (in)	N/A
	X Walk 1 Slope (%)	0.6		X Walk 2 Slope (%)	N/A
	X Walk 1 X Slope (%)	3.6		X Walk 2 X Slope (%)	N/A

N/A	Ramp inside XWalk1?	N/A	N/A	Ramp inside XWalk2?	N/A
	Road Slope (%)	N/A	N/A	Clear Space?	N/A
	Road X Slope (%)	N/A	N/A	Clear Space to XWalk (in)	N/A
N/A	Any Obstructions?	N/A	N/A	Storm Grate/Utility Hazard?	N/A
	Obstruction Type			Storm Grate/Utility Type	
		N/A			N/A
			Yes	Surface Condition? (G/P)	Good

Possible Solutions:

Remove & Replace Entire Ramp.
