Access Compliance Report

Public Rights-of-Way

(Curb Ramps)

Intersection ID: N/A	Main Street: SOUTHGROVE_ST	Cross Street: WAVERLY_WALK_AV	Location: NE
ADA ID: 20F8D79EA161	Ramp Type: Perp	Initial Pass/Fail: Fail	Overall Compliance: No
		Severity Score: 1.25

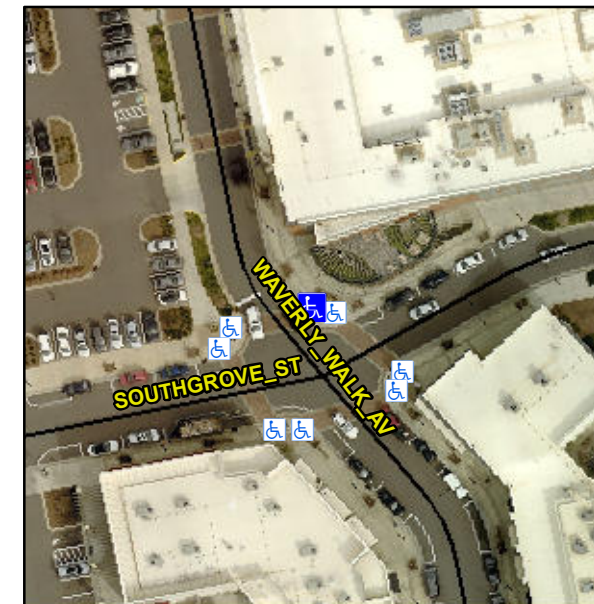
Not Found, R304.5.3

Compliance	Description	Data	Compliance	Description	Data
N/A	Ramp Length (in)	72.0	Yes	Ramp Slope (%)	7.4
Yes	Ramp Width (in)	48.0	No	Ramp XSlope (%)	2.4
N/A	Flare Type LT	N/A	N/A	Flare Type RT	N/A
N/A	Flare Slope LT (%)	N/A	N/A	Flare Slope RT (%)	N/A
N/A	Flare Traversable LT?	N/A	N/A	Flare Traversable RT?	N/A
N/A	Landing Length (in)	N/A	N/A	DWS Provided?	N/A
N/A	Landing Width (in)	N/A	N/A	DWS Contrast?	N/A
N/A	Landing Slope (%)	N/A	N/A	DWS Length (in)	N/A
N/A	Landing X Slope (%)	N/A	N/A	DWS Full Width?	N/A
N/A	Landing Curb? (Y/N)	N/A	N/A	DWS Offset (in)	N/A
N/A	Shared Landing?	N/A			
N/A	Gutter Ponding?	N/A	N/A	Gutter Slope (%)	N/A
N/A	Gutter Lip Ht (in)	N/A	N/A	Gutter X Slope (%)	N/A
N/A	Painted X Walk1?	Yes	N/A	Painted X Walk2?	N/A
	X Walk 1 Direction	To W		X Walk 2 Direction	N/A
N/A	X Walk 1 Width (in)	103.0	N/A	X Walk 2 Width (in)	N/A
	X Walk 1 Slope (%)	0.6		X Walk 2 Slope (%)	N/A
	X Walk 1 X Slope (%)	1.3		X Walk 2 X Slope (%)	N/A

N/A	Ramp inside XWalk1?	Yes	N/A	Ramp inside XWalk2?	N/A
	Road Slope (%)	N/A	N/A	Clear Space?	N/A
	Road X Slope (%)	N/A	N/A	Clear Space to XWalk (in)	N/A
N/A	Any Obstructions?	N/A	N/A	Storm Grate/Utility Hazard?	N/A
	Obstruction Type			Storm Grate/Utility Type	
		N/A			N/A
			Yes	Surface Condition? (G/P)	Good

Remove & Replace Entire Ramp.
