# Access Compliance Report

## Public Rights-of-Way

| Intersection ID: 53233 | Main Street: FLEETWOOD_DR | Cross Street: HORNETS_NEST_WY | Location: NW |
| ADA ID: 20FBB3870FE6 | Ramp Type: BlendTrans1 | Initial Pass/Fail: Fail | Overall Compliance: No |

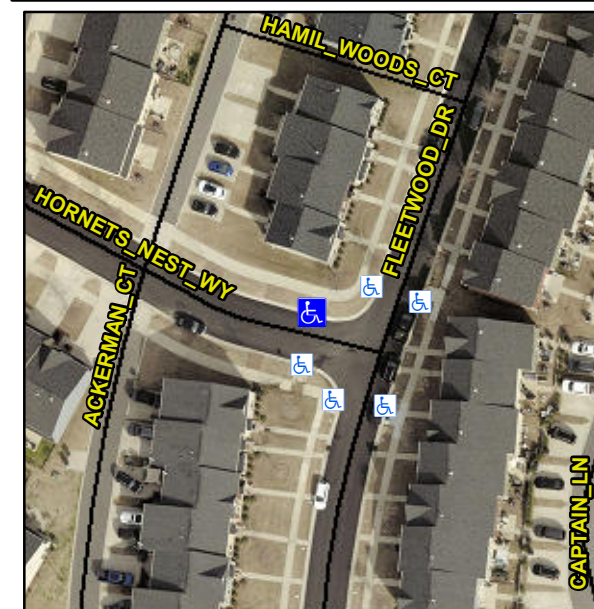
| Severity Score: 21.25 | | | |

**Not Found, R304.5.1, R304.5.3**

| Compliance | Description | Data | Compliance | Description | Data |
|---|---|---|---|---|---|
| No | Ramp Width (in) | 47.0 | No | BlendTrans XSlope (%) | 6.3 |

**Remove & Replace Curb Ramp With Two New Directional Ramps or Equivalent.**

Total Cost: \$ 3200.00

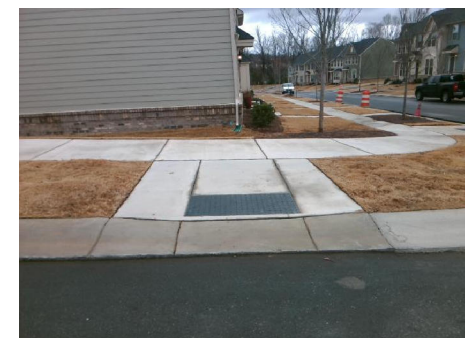
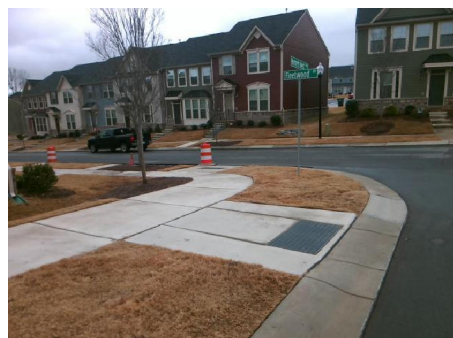
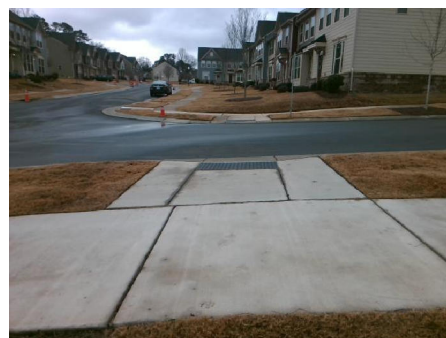
| Compliance | Description | Data | Compliance | Description | Data |
|---|---|---|---|---|---|
| N/A | Ramp Length (in) | 94.5 | Yes | BlendTrans Slope (%) | 0.4 |
| | | | No | Curb Slope (%) | 11.8 |
