Access Compliance Report

Public Rights-of-Way

(Curb Ramps)

Intersection ID: 31633	Main Street: KARAM_LN	Cross Street: MARY_JO_HELMS_DR	Location: SE
ADA ID: 20FD3B52F3C2	Ramp Type: PerpDiag	Initial Pass/Fail: Fail	Overall Compliance: No
Severity Score: 25			
Codes/Mitigation Info/Possible Solution		Field Measurements/Component Compliance

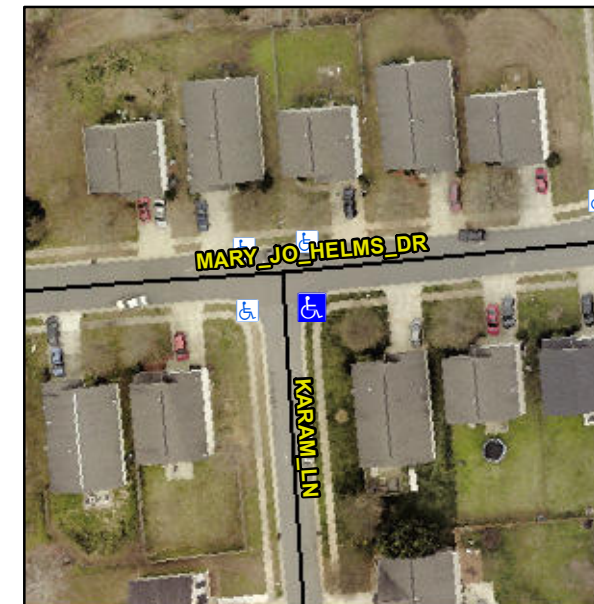
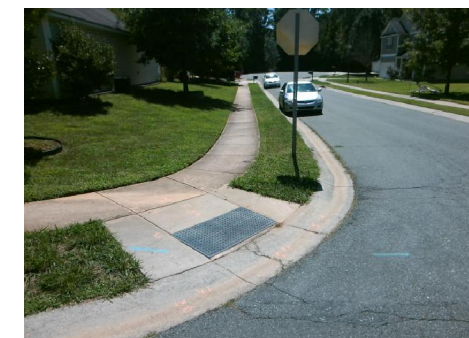
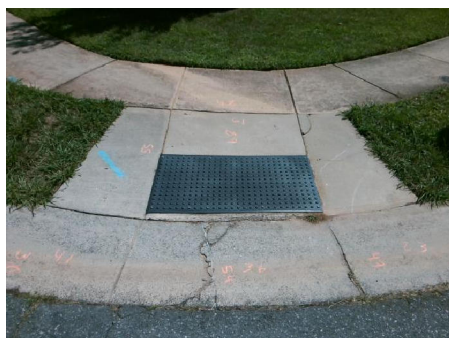
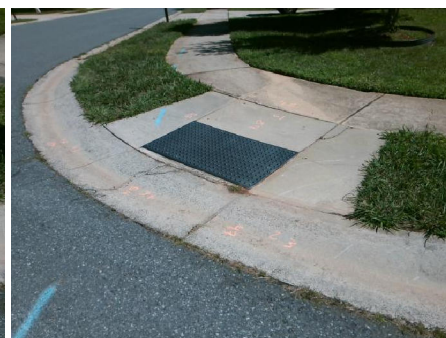
Not Found, R304.2.2, R304.5.3

Compliance	Description	Data	Compliance	Description	Data
N/A	Ramp Length (in)	55.0	No	Ramp Slope (%)	8.9
Yes	Ramp Width (in)	48.0	No	Ramp XSlope (%)	6.1
N/A	Flare Type LT	N/A	N/A	Flare Type RT	N/A
N/A	Flare Slope LT (%)	N/A	N/A	Flare Slope RT (%)	N/A
N/A	Flare Traversable LT?	N/A	N/A	Flare Traversable RT?	N/A
N/A	Landing Length (in)	N/A	N/A	DWS Provided?	N/A
N/A	Landing Width (in)	N/A	N/A	DWS Contrast?	N/A
N/A	Landing Slope (%)	N/A	N/A	DWS Length (in)	N/A
N/A	Landing X Slope (%)	N/A	N/A	DWS Full Width?	N/A
N/A	Landing Curb? (Y/N)	N/A	N/A	DWS Offset (in)	N/A
N/A	Shared Landing?	N/A			
N/A	Gutter Ponding?	N/A	N/A	Gutter Slope (%)	N/A
N/A	Gutter Lip Ht (in)	N/A	N/A	Gutter X Slope (%)	N/A
N/A	Painted X Walk1?	No	N/A	Painted X Walk2?	No
	X Walk 1 Direction	To N		X Walk 2 Direction	To W
N/A	X Walk 1 Width (in)	N/A	N/A	X Walk 2 Width (in)	N/A
	X Walk 1 Slope (%)	3.0		X Walk 2 Slope (%)	4.7
	X Walk 1 X Slope (%)	4.1		X Walk 2 X Slope (%)	2.3

N/A	Ramp inside XWalk1?	N/A	N/A	Ramp inside XWalk2?	N/A
	Road Slope (%)	5.4	N/A	Clear Space?	N/A
	Road X Slope (%)	3.6	N/A	Clear Space to XWalk (in)	N/A
N/A	Any Obstructions?	N/A	N/A	Storm Grate/Utility Hazard?	N/A
	Obstruction Type			Storm Grate/Utility Type	
		N/A			N/A
		Yes		Surface Condition? (G/P)	Good

Remove & Replace Curb Ramp With Two New Directional Ramps or Equivalent.
