Access Compliance Report

Public Rights-of-Way

(Curb Ramps)

Intersection ID: 51060	Main Street: CRAIGMOSS_LN	Cross Street: TIPPERLINN_WY	Location: NW
ADA ID: 21003E62949A	Ramp Type: PerpDiag	Initial Pass/Fail: Fail	Overall Compliance: No
Severity Score: 12.5			
Codes/Mitigation Info/Possible Solution		Field Measurements/Component Compliance

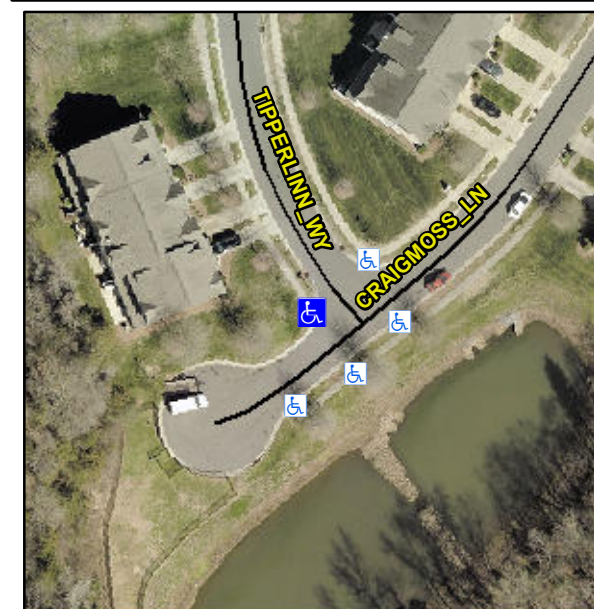
Compliance	Description	Data	Compliance	Description	Data
N/A	Ramp Length (in)	48.0	Yes	Ramp Slope (%)	7.6
Yes	Ramp Width (in)	48.0	No	Ramp XSlope (%)	5.4
N/A	Flare Type LT	N/A	N/A	Flare Type RT	N/A
N/A	Flare Slope LT (%)	N/A	N/A	Flare Slope RT (%)	N/A
N/A	Flare Traversable LT?	N/A	N/A	Flare Traversable RT?	N/A
N/A	Landing Length (in)	N/A	N/A	DWS Provided?	N/A
N/A	Landing Width (in)	N/A	N/A	DWS Contrast?	N/A
N/A	Landing Slope (%)	N/A	N/A	DWS Length (in)	N/A
N/A	Landing X Slope (%)	N/A	N/A	DWS Full Width?	N/A
N/A	Landing Curb? (Y/N)	N/A	N/A	DWS Offset (in)	N/A
N/A	Shared Landing?	N/A			
N/A	Gutter Ponding?	N/A	N/A	Gutter Slope (%)	N/A
N/A	Gutter Lip Ht (in)	N/A	N/A	Gutter X Slope (%)	N/A
N/A	Painted X Walk1?	No	N/A	Painted X Walk2?	No
	X Walk 1 Direction	To SE		X Walk 2 Direction	To NE
N/A	X Walk 1 Width (in)	N/A	N/A	X Walk 2 Width (in)	N/A
	X Walk 1 Slope (%)	1.6		X Walk 2 Slope (%)	1.0
	X Walk 1 X Slope (%)	2.9		X Walk 2 X Slope (%)	0.8

N/A	Ramp inside XWalk1?	N/A	N/A	Ramp inside XWalk2?	N/A
	Road Slope (%)	2.4	N/A	Clear Space?	N/A
	Road X Slope (%)	1.2	N/A	Clear Space to XWalk (in)	N/A
N/A	Any Obstructions?	N/A	N/A	Storm Grate/Utility Hazard?	N/A
	Obstruction Type			Storm Grate/Utility Type	
		N/A			N/A
			Yes	Surface Condition? (G/P)	Good

Remove & Replace Curb Ramp With Two New Directional Ramps or Equivalent.

R304.5.3

\$ 3200.00
