Access Compliance Report

Public Rights-of-Way

(Curb Ramps)

Intersection ID: 43662	Main Street: HUNTINGTON_MEADOW_LN	Cross Street: CORSICA_FOREST_DR	Location: SW
ADA ID: 210D6B118C93	Ramp Type: PerpDiag	Initial Pass/Fail: Fail	Overall Compliance: No
Codes/Mitigation Info/Possible Solution		Field Measurements/Component Compliance

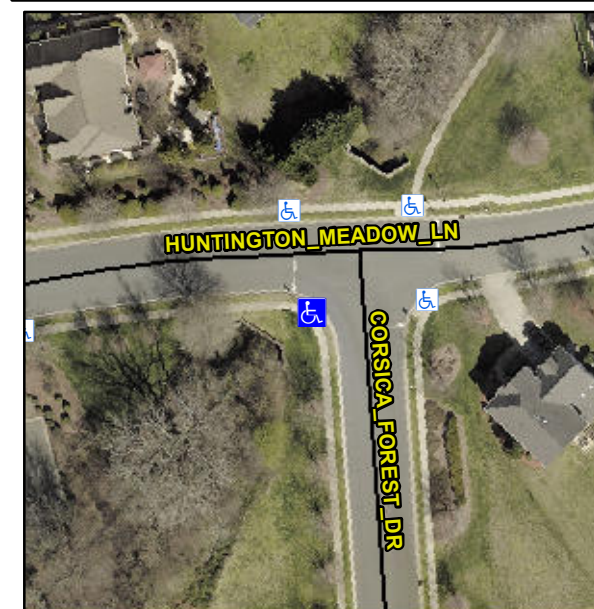
R304.5.1, R304.5.3

Compliance	Description	Data	Compliance	Description	Data
N/A	Ramp Length (in)	96.0	Yes	Ramp Slope (%)	6.7
No	Ramp Width (in)	44.0	No	Ramp XSlope (%)	3.6
N/A	Flare Type LT	N/A	N/A	Flare Type RT	N/A
N/A	Flare Slope LT (%)	N/A	N/A	Flare Slope RT (%)	N/A
N/A	Flare Traversable LT?	N/A	N/A	Flare Traversable RT?	N/A
N/A	Landing Length (in)	N/A	N/A	DWS Provided?	N/A
N/A	Landing Width (in)	N/A	N/A	DWS Contrast?	N/A
N/A	Landing Slope (%)	N/A	N/A	DWS Length (in)	N/A
N/A	Landing X Slope (%)	N/A	N/A	DWS Full Width?	N/A
N/A	Landing Curb? (Y/N)	N/A	N/A	DWS Offset (in)	N/A
N/A	Shared Landing?	N/A			
N/A	Gutter Ponding?	N/A	N/A	Gutter Slope (%)	N/A
N/A	Gutter Lip Ht (in)	N/A	N/A	Gutter X Slope (%)	N/A
N/A	Painted X Walk1?	No	N/A	Painted X Walk2?	No
	X Walk 1 Direction	To E		X Walk 2 Direction	To N
N/A	X Walk 1 Width (in)	N/A	N/A	X Walk 2 Width (in)	N/A
	X Walk 1 Slope (%)	2.2		X Walk 2 Slope (%)	2.1
	X Walk 1 X Slope (%)	0.1		X Walk 2 X Slope (%)	1.4

N/A	Ramp inside XWalk1?	N/A	N/A	Ramp inside XWalk2?	N/A
	Road Slope (%)	1.0	N/A	Clear Space?	N/A
	Road X Slope (%)	5.1	N/A	Clear Space to XWalk (in)	N/A
N/A	Any Obstructions?	N/A	N/A	Storm Grate/Utility Hazard?	N/A
	Obstruction Type			Storm Grate/Utility Type	
		N/A			N/A
			Yes	Surface Condition? (G/P)	Good

Possible Solutions:

Remove & Replace Curb Ramp With Two New Directional Ramps or Equivalent.
