Access Compliance Report

Public Rights-of-Way

(Curb Ramps)

Intersection ID: 47836	Main Street: ALVARADO_WY	Cross Street: DRAGONFLY_LN	Location: W
ADA ID: 21194D0128F0	Ramp Type: Perp	Initial Pass/Fail: Fail	Overall Compliance: No
Severity Score: 21.25			
Codes/Mitigation Info/Possible Solution		Field Measurements/Component Compliance

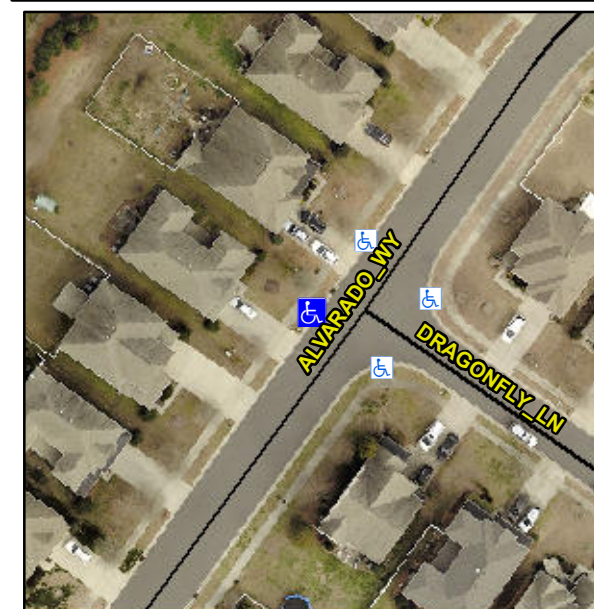
Not Found, R304.5.1, R304.2.2

Compliance	Description	Data	Compliance	Description	Data
N/A	Ramp Length (in)	72.0	No	Ramp Slope (%)	11.2
No	Ramp Width (in)	47.0	Yes	Ramp XSlope (%)	1.8
N/A	Flare Type LT	N/A	N/A	Flare Type RT	N/A
N/A	Flare Slope LT (%)	N/A	N/A	Flare Slope RT (%)	N/A
N/A	Flare Traversable LT?	N/A	N/A	Flare Traversable RT?	N/A
N/A	Landing Length (in)	N/A	N/A	DWS Provided?	N/A
N/A	Landing Width (in)	N/A	N/A	DWS Contrast?	N/A
N/A	Landing Slope (%)	N/A	N/A	DWS Length (in)	N/A
N/A	Landing X Slope (%)	N/A	N/A	DWS Full Width?	N/A
N/A	Landing Curb? (Y/N)	N/A	N/A	DWS Offset (in)	N/A
N/A	Shared Landing?	N/A			
N/A	Gutter Ponding?	N/A	N/A	Gutter Slope (%)	N/A
N/A	Gutter Lip Ht (in)	N/A	N/A	Gutter X Slope (%)	N/A
N/A	Painted X Walk1?	No	N/A	Painted X Walk2?	N/A
	X Walk 1 Direction	To SE		X Walk 2 Direction	N/A
N/A	X Walk 1 Width (in)	N/A	N/A	X Walk 2 Width (in)	N/A
	X Walk 1 Slope (%)	3.1		X Walk 2 Slope (%)	N/A
	X Walk 1 X Slope (%)	1.2		X Walk 2 X Slope (%)	N/A

N/A	Ramp inside XWalk1?	N/A	N/A	Ramp inside XWalk2?	N/A
	Road Slope (%)	N/A	N/A	Clear Space?	N/A
	Road X Slope (%)	N/A	N/A	Clear Space to XWalk (in)	N/A
N/A	Any Obstructions?	N/A	N/A	Storm Grate/Utility Hazard?	N/A
	Obstruction Type			Storm Grate/Utility Type	
		N/A			N/A
			Yes	Surface Condition? (G/P)	Good

Possible Solutions:

Remove & Replace Entire Ramp.
