Access Compliance Report Public Rights-of-Way (Curb Ramps)

Intersection ID: 48159 Main Street: MT_HOLLY-HUNTERSVILLE_RIDCross Street: NORTHLAKE_CENTRE_PY Location: SW

ADA ID: 211BB67EB991 Ramp Type: Combination1 Initial Pass/Fail: Fail Overall Compliance: No Severity Score: 10

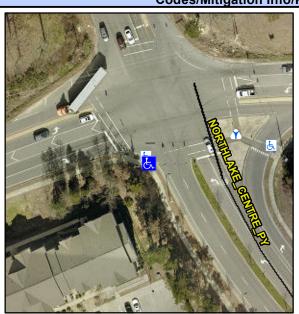
Possible Solutions:						
Remove & Replace Entire Ramp.						
·						
Sum rover Notes						
Surveyor Notes:						
N/A						
PROW/ADA:						
Not Found, R304.5.1, R304.5.3						
,
