# Access Compliance Report

## Public Rights-of-Way

### (Curb Ramps)

Intersection ID: 11774	Main Street: PHIFER_AV	Cross Street: N_TRYON_ST	Location: S
ADA ID: 211E7325CBA6	Ramp Type: PerpDiag	Initial Pass/Fail: Fail	Overall Compliance: No
			Severity Score: 21.25

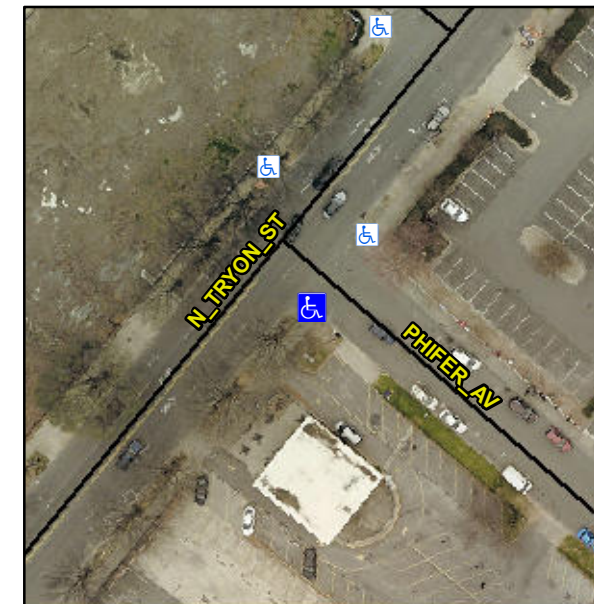
**Not Found, R304.5.1, R304.2.2**

Compliance	Description	Data	Compliance	Description	Data
N/A	Ramp Length (in)	62.0	No	Ramp Slope (%)	9.0
No	Ramp Width (in)	41.0	Yes	Ramp XSlope (%)	1.8
N/A	Flare Type LT	N/A	N/A	Flare Type RT	N/A
N/A	Flare Slope LT (%)	N/A	N/A	Flare Slope RT (%)	N/A
N/A	Flare Traversable LT?	N/A	N/A	Flare Traversable RT?	N/A
N/A	Landing Length (in)	N/A	N/A	DWS Provided?	N/A
N/A	Landing Width (in)	N/A	N/A	DWS Contrast?	N/A
N/A	Landing Slope (%)	N/A	N/A	DWS Length (in)	N/A
N/A	Landing X Slope (%)	N/A	N/A	DWS Full Width?	N/A
N/A	Landing Curb? (Y/N)	N/A	N/A	DWS Offset (in)	N/A
N/A	Shared Landing?	N/A			
N/A	Gutter Ponding?	N/A	N/A	Gutter Slope (%)	N/A
N/A	Gutter Lip Ht (in)	N/A	N/A	Gutter X Slope (%)	N/A
N/A	Painted X Walk1?	No	N/A	Painted X Walk2?	No
	X Walk 1 Direction	To NE		X Walk 2 Direction	To NW
N/A	X Walk 1 Width (in)	N/A	N/A	X Walk 2 Width (in)	N/A
	X Walk 1 Slope (%)	7.7		X Walk 2 Slope (%)	3.7
	X Walk 1 X Slope (%)	3.0		X Walk 2 X Slope (%)	3.7

N/A	Ramp inside XWalk1?	N/A	N/A	Ramp inside XWalk2?	N/A
	Road Slope (%)	0.1	N/A	Clear Space?	N/A
	Road X Slope (%)	8.4	N/A	Clear Space to XWalk (in)	N/A
N/A	Any Obstructions?	N/A	N/A	Storm Grate/Utility Hazard?	N/A
	Obstruction Type			Storm Grate/Utility Type	
		N/A			N/A
			Yes	Surface Condition? (G/P)	Good

**Remove & Replace Curb Ramp With Two New Directional Ramps or Equivalent.**

Total Cost: \$ 3200.00
