# Access Compliance Report

## Public Rights-of-Way

### (Curb Ramps)

Intersection ID: 15675	Main Street: EAST_BV	Cross Street: LOMBARDY_CR	Location: SW
ADA ID: 211F1AA44648	Ramp Type: PerpDiag	Initial Pass/Fail: Fail	Overall Compliance: No
Codes/Mitigation Info/Possible Solution		Field Measurements/Component Compliance	
Severity Score: 12.5

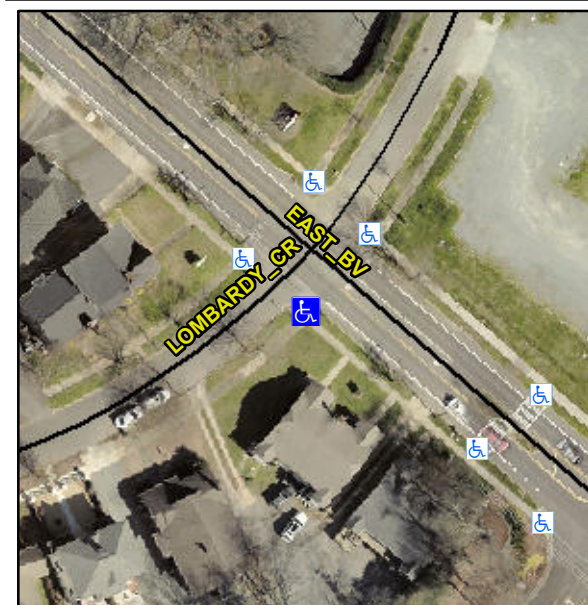
Compliance	Description	Data	Compliance	Description	Data
N/A	Ramp Length (in)	39.0	No	Ramp Slope (%)	10.9
Yes	Ramp Width (in)	48.0	Yes	Ramp XSlope (%)	1.4
N/A	Flare Type LT	N/A	N/A	Flare Type RT	N/A
N/A	Flare Slope LT (%)	N/A	N/A	Flare Slope RT (%)	N/A
N/A	Flare Traversable LT?	N/A	N/A	Flare Traversable RT?	N/A
N/A	Landing Length (in)	N/A	N/A	DWS Provided?	N/A
N/A	Landing Width (in)	N/A	N/A	DWS Contrast?	N/A
N/A	Landing Slope (%)	N/A	N/A	DWS Length (in)	N/A
N/A	Landing X Slope (%)	N/A	N/A	DWS Full Width?	N/A
N/A	Landing Curb? (Y/N)	N/A	N/A	DWS Offset (in)	N/A
N/A	Shared Landing?	N/A			
N/A	Gutter Ponding?	N/A	N/A	Gutter Slope (%)	N/A
N/A	Gutter Lip Ht (in)	N/A	N/A	Gutter X Slope (%)	N/A
N/A	Painted X Walk1?	No	N/A	Painted X Walk2?	No
	X Walk 1 Direction	To NE		X Walk 2 Direction	To NW
N/A	X Walk 1 Width (in)	N/A	N/A	X Walk 2 Width (in)	N/A
	X Walk 1 Slope (%)	3.4		X Walk 2 Slope (%)	4.1
	X Walk 1 X Slope (%)	2.5		X Walk 2 X Slope (%)	0.7

N/A	Ramp inside XWalk1?	N/A	N/A	Ramp inside XWalk2?	N/A
	Road Slope (%)	1.7	N/A	Clear Space?	N/A
	Road X Slope (%)	5.0	N/A	Clear Space to XWalk (in)	N/A
N/A	Any Obstructions?	N/A	N/A	Storm Grate/Utility Hazard?	N/A
	Obstruction Type			Storm Grate/Utility Type	
		N/A			N/A
			Yes	Surface Condition? (G/P)	Good

Possible Solutions:

**Remove & Replace Curb Ramp With Two New Directional Ramps or Equivalent.**
