Access Compliance Report

Public Rights-of-Way

(Curb Ramps)

Intersection ID: 9953	Main Street: TRIANGLE_DR	Cross Street: TUCKASEEGEE_RD	Location: SE
ADA ID: 21266FE2B0F9	Ramp Type: Perp	Initial Pass/Fail: Fail	Overall Compliance: No
Severity Score: 21.25			
Codes/Mitigation Info/Possible Solution		Field Measurements/Component Compliance

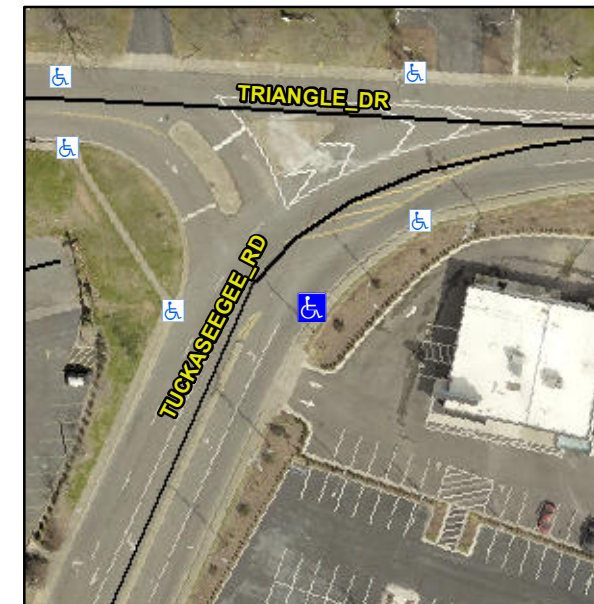
Not Found, R304.5.1, R304.2.2

Compliance	Description	Data	Compliance	Description	Data
N/A	Ramp Length (in)	49.0	No	Ramp Slope (%)	9.3
No	Ramp Width (in)	41.5	Yes	Ramp XSlope (%)	1.1
N/A	Flare Type LT	N/A	N/A	Flare Type RT	N/A
N/A	Flare Slope LT (%)	N/A	N/A	Flare Slope RT (%)	N/A
N/A	Flare Traversable LT?	N/A	N/A	Flare Traversable RT?	N/A
N/A	Landing Length (in)	N/A	N/A	DWS Provided?	N/A
N/A	Landing Width (in)	N/A	N/A	DWS Contrast?	N/A
N/A	Landing Slope (%)	N/A	N/A	DWS Length (in)	N/A
N/A	Landing X Slope (%)	N/A	N/A	DWS Full Width?	N/A
N/A	Landing Curb? (Y/N)	N/A	N/A	DWS Offset (in)	N/A
N/A	Shared Landing?	N/A			
N/A	Gutter Ponding?	N/A	N/A	Gutter Slope (%)	N/A
N/A	Gutter Lip Ht (in)	N/A	N/A	Gutter X Slope (%)	N/A
N/A	Painted X Walk1?	No	N/A	Painted X Walk2?	N/A
	X Walk 1 Direction	To NW		X Walk 2 Direction	N/A
N/A	X Walk 1 Width (in)	N/A	N/A	X Walk 2 Width (in)	N/A
	X Walk 1 Slope (%)	4.6		X Walk 2 Slope (%)	N/A
	X Walk 1 X Slope (%)	0.3		X Walk 2 X Slope (%)	N/A

N/A	Ramp inside XWalk1?	N/A	N/A	Ramp inside XWalk2?	N/A
	Road Slope (%)	N/A	N/A	Clear Space?	N/A
	Road X Slope (%)	N/A	N/A	Clear Space to XWalk (in)	N/A
N/A	Any Obstructions?	N/A	N/A	Storm Grate/Utility Hazard?	N/A
	Obstruction Type			Storm Grate/Utility Type	
		N/A			N/A
			Yes	Surface Condition? (G/P)	Good

Remove & Replace Entire Ramp.
