## Access Compliance Report Public Rights-of-Way (Curb Ramps)

Intersection ID: 48985 Main Street: AVONCLIFF\_DR Cross Street: KINGSDOWN\_AV Location: SW

ADA ID: 21374AFDA802 Ramp Type: PerpDiag Initial Pass/Fail: Fail Overall Compliance: No Severity Score: 33.75

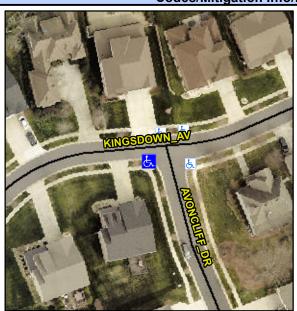
Field Measurements/Component Compliance						
Compliance Description		Data	Comp	oliance Description	Data	
1	N/A	Ramp Length (in)	69.0	Yes	Ramp Slope (%)	7.2
1	No	Ramp Width (in)	47.5	No	Ramp XSlope (%)	7.4
N	N/A	Flare Type LT	N/A	N/A	Flare Type RT	N/A
1	N/A	Flare Slope LT (%)	N/A	N/A	Flare Slope RT (%)	N/A
1	N/A	Flare Traversable LT?	N/A	N/A	Flare Traversable RT?	N/A
1	N/A	Landing Length (in)	N/A	N/A	DWS Provided?	N/A
1	N/A	Landing Width (in)	N/A	N/A	DWS Contrast?	N/A
1	N/A	Landing Slope (%)	N/A	N/A	DWS Length (in)	N/A
1	N/A	Landing X Slope (%)	N/A	N/A	DWS Full Width?	N/A
1	N/A	Landing Curb? (Y/N)	N/A	N/A	DWS Offset (in)	N/A
1	N/A	Shared Landing?	N/A			
1	N/A	Gutter Ponding?	N/A	N/A	Gutter Slope (%)	N/A
N	N/A	Gutter Lip Ht (in)	N/A	N/A	Gutter X Slope (%)	N/A
1	N/A	Painted X Walk1?	No	N/A	Painted X Walk2?	No
		X Walk 1 Direction	То Е		X Walk 2 Direction	To N
1	N/A	X Walk 1 Width (in)	N/A	N/A	X Walk 2 Width (in)	N/A

X Walk 1 Slope (%)	4.8		X Walk 2 Slope (%)	3.4
		X Walk 1 X Slope (%)	0.2		X Walk 2 X Slope (%)	6.6
1	N/A	Ramp inside XWalk1?	N/A	N/A	Ramp inside XWalk2?	N/A
		Road Slope (%)	5.4	N/A	Clear Space?	N/A
		Road X Slope (%)	2.9	N/A	Clear Space to XWalk (in)	N/A
1	N/A	Any Obstructions?	N/A	N/A	Storm Grate/Utility Hazard?	N/A
		Obstruction Type			Storm Grate/Utility Type	
			N/A			N/A
				Yes	Surface Condition? (G/P)	Good

Remove & Replace Curb Ramp With
Two New Directional Ramps or
Equivalent.
