Access Compliance Report

Public Rights-of-Way

(Curb Ramps)

Intersection ID: N/A	Main Street: TRYON_ST	Cross Street: I-485	Location: SE
ADA ID: 21387DB83910	Ramp Type: PerpDiag	Initial Pass/Fail: Fail	Overall Compliance: No
Codes/Mitigation Info/Possible Solution		Field Measurements/Component Compliance	
Severity Score: 13.75

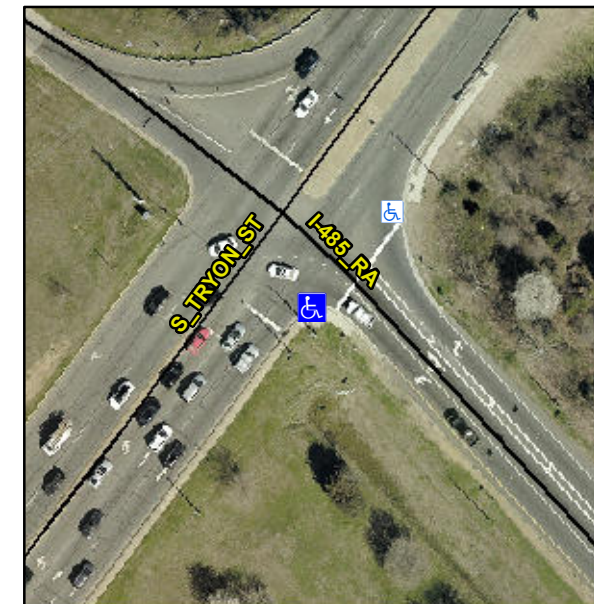
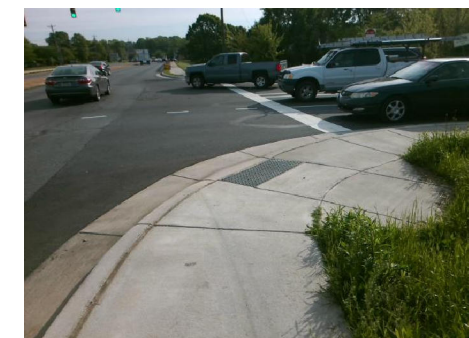
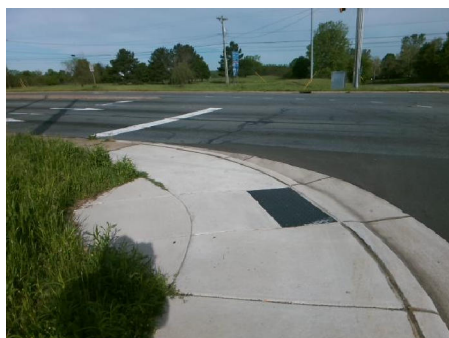
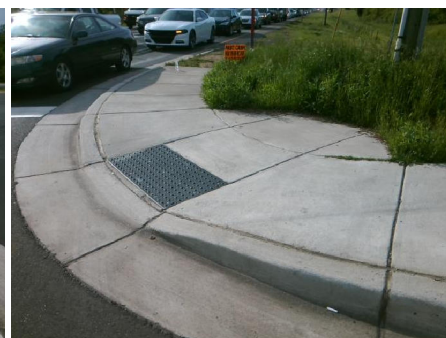
R304.2.2

Compliance	Description	Data	Compliance	Description	Data
N/A	Ramp Length (in)	52.0	No	Ramp Slope (%)	8.9
Yes	Ramp Width (in)	48.0	Yes	Ramp XSlope (%)	2.5
N/A	Flare Type LT	N/A	N/A	Flare Type RT	N/A
N/A	Flare Slope LT (%)	N/A	N/A	Flare Slope RT (%)	N/A
N/A	Flare Traversable LT?	N/A	N/A	Flare Traversable RT?	N/A
N/A	Landing Length (in)	N/A	N/A	DWS Provided?	N/A
N/A	Landing Width (in)	N/A	N/A	DWS Contrast?	N/A
N/A	Landing Slope (%)	N/A	N/A	DWS Length (in)	N/A
N/A	Landing X Slope (%)	N/A	N/A	DWS Full Width?	N/A
N/A	Landing Curb? (Y/N)	N/A	N/A	DWS Offset (in)	N/A
N/A	Shared Landing?	N/A			
N/A	Gutter Ponding?	N/A	N/A	Gutter Slope (%)	N/A
N/A	Gutter Lip Ht (in)	N/A	N/A	Gutter X Slope (%)	N/A
N/A	Painted X Walk1?	No	N/A	Painted X Walk2?	No
	X Walk 1 Direction	To NE		X Walk 2 Direction	To NW
N/A	X Walk 1 Width (in)	N/A	N/A	X Walk 2 Width (in)	N/A
	X Walk 1 Slope (%)	4.1		X Walk 2 Slope (%)	2.0
	X Walk 1 X Slope (%)	2.1		X Walk 2 X Slope (%)	1.3

N/A	Ramp inside XWalk1?	N/A	N/A	Ramp inside XWalk2?	N/A
	Road Slope (%)	3.0	N/A	Clear Space?	N/A
	Road X Slope (%)	0.0	N/A	Clear Space to XWalk (in)	N/A
N/A	Any Obstructions?	N/A	N/A	Storm Grate/Utility Hazard?	N/A
	Obstruction Type			Storm Grate/Utility Type	
		N/A			N/A
		Yes		Surface Condition? (G/P)	Good

Remove & Replace Curb Ramp With Two New Directional Ramps or Equivalent.

\$ 3200.00
