# Access Compliance Report

## Public Rights-of-Way

### (Curb Ramps)

Intersection ID: 27404	Main Street: BALLANTYNE COMMONS PY	Cross Street: MEADOW RUN LN	Location: SW
ADA ID: 21390999313A	Ramp Type: Perp	Initial Pass/Fail: Fail	Overall Compliance: No
Codes/Mitigation Info/Possible Solution		Field Measurements/Component Compliance	
Severity Score: 21.25

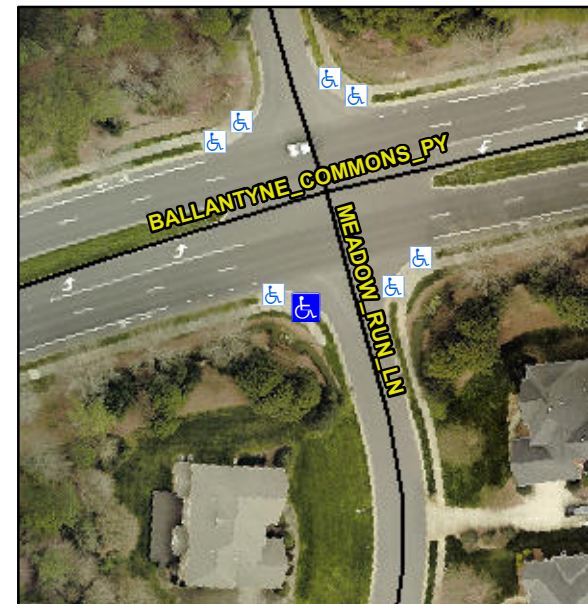
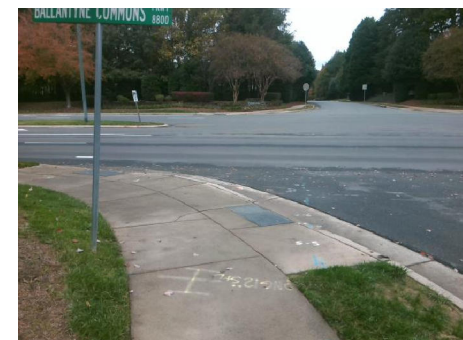
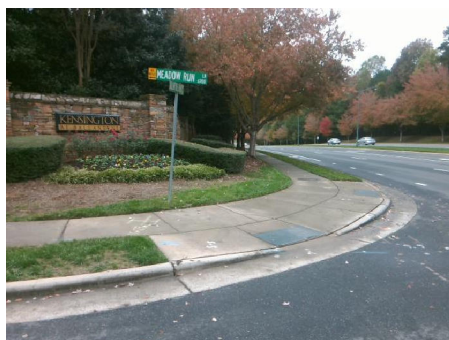
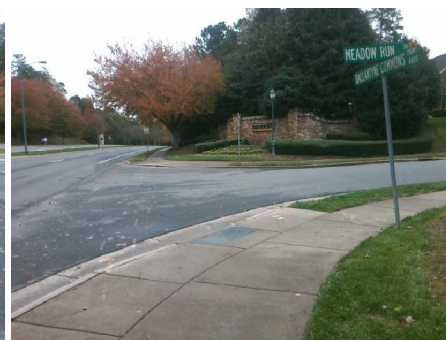
**Not Found, R304.5.1, R304.2.2**

Compliance	Description	Data	Compliance	Description	Data
N/A	Ramp Length (in)	107.0	No	Ramp Slope (%)	8.5
No	Ramp Width (in)	42.0	Yes	Ramp XSlope (%)	1.3
N/A	Flare Type LT	N/A	N/A	Flare Type RT	N/A
N/A	Flare Slope LT (%)	N/A	N/A	Flare Slope RT (%)	N/A
N/A	Flare Traversable LT?	N/A	N/A	Flare Traversable RT?	N/A
N/A	Landing Length (in)	N/A	N/A	DWS Provided?	N/A
N/A	Landing Width (in)	N/A	N/A	DWS Contrast?	N/A
N/A	Landing Slope (%)	N/A	N/A	DWS Length (in)	N/A
N/A	Landing X Slope (%)	N/A	N/A	DWS Full Width?	N/A
N/A	Landing Curb? (Y/N)	N/A	N/A	DWS Offset (in)	N/A
N/A	Shared Landing?	N/A			
N/A	Gutter Ponding?	N/A	N/A	Gutter Slope (%)	N/A
N/A	Gutter Lip Ht (in)	N/A	N/A	Gutter X Slope (%)	N/A
N/A	Painted X Walk1?	No	N/A	Painted X Walk2?	N/A
	X Walk 1 Direction	To E		X Walk 2 Direction	N/A
N/A	X Walk 1 Width (in)	N/A	N/A	X Walk 2 Width (in)	N/A
	X Walk 1 Slope (%)	4.9		X Walk 2 Slope (%)	N/A
	X Walk 1 X Slope (%)	0.8		X Walk 2 X Slope (%)	N/A

N/A	Ramp inside XWalk1?	N/A	N/A	Ramp inside XWalk2?	N/A
	Road Slope (%)	N/A	N/A	Clear Space?	N/A
	Road X Slope (%)	N/A	N/A	Clear Space to XWalk (in)	N/A
N/A	Any Obstructions?	N/A	N/A	Storm Grate/Utility Hazard?	N/A
	Obstruction Type			Storm Grate/Utility Type	
		N/A			N/A
			Yes	Surface Condition? (G/P)	Good

**Remove & Replace Entire Ramp.**
