Access Compliance Report

Public Rights-of-Way

(Curb Ramps)

Intersection ID: 10637	Main Street: COKER_AV	Cross Street: MATHIS_DR	Location: E
ADA ID: 21395B16DBCD	Ramp Type: Directional1	Initial Pass/Fail: Fail	Overall Compliance: No
Codes/Mitigation Info/Possible Solution		Field Measurements/Component Compliance	
Severity Score: 1.25

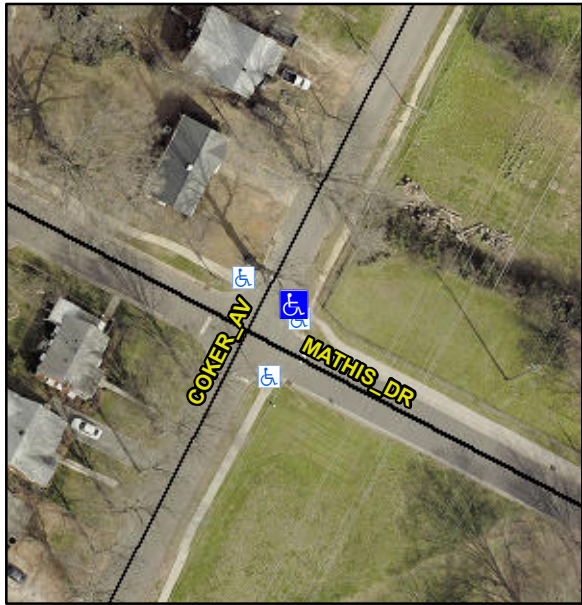
Compliance	Description	Data	Compliance	Description	Data
N/A	Ramp Length (in)	48.0	N/A	Grade Break?	N/A
Yes	Ramp Width (in)	58.0	N/A	Grade Break Slope (%)	0.0
Yes	Ramp Slope (%)	7.9	N/A	Grade Break XSlope (%)	0.0
No	Ramp XSlope (%)	4.3			
N/A	Flare Type LT	N/A	N/A	Flare Type RT	N/A
N/A	Flare Slope LT (%)	N/A	N/A	Flare Slope RT (%)	0.0
N/A	Flare Traversable LT?	N/A	N/A	Flare Traversable RT?	N/A
N/A	Landing Length (in)	0.0	N/A	DWS Provided?	N/A
N/A	Landing Width (in)	0.0	N/A	DWS Contrast?	N/A
N/A	Landing Slope (%)	0.0	N/A	DWS Length (in)	N/A
N/A	Landing X Slope (%)	0.0	N/A	DWS Full Width?	N/A
N/A	Landing Curb? (Y/N)	N/A	N/A	DWS Offset LT (in)	N/A
N/A	Shared Landing?	N/A	N/A	DWS Offset RT (in)	N/A
N/A	Gutter Ponding?	0.0	N/A	Gutter Slope (%)	N/A
N/A	Gutter Lip Ht (in)	0.5	N/A	Gutter X Slope (%)	N/A
N/A	Painted X Walk1?	No		Road Slope (%)	1.2
	X Walk 1 Direction	To NW		Road X Slope (%)	2.5
	X Walk 1 Width (in)	N/A		Clear Space?	N/A

X Walk 1 Slope (%)	1.2	N/A	Clear Space to XWalk (in)	N/A
	X Walk 1 X Slope (%)	2.5	N/A	Storm Grate/Utility Hazard?	N/A
N/A	Ramp inside XWalk1?	N/A		Storm Grate/Utility Type	
N/A	Any Obstructions?	N/A			N/A
	Obstruction Type		Yes	Surface Condition? (G/P)	Good
		N/A	N/A	Curb Slope (%)	12.9

Possible Solutions:

Remove & Replace Entire Ramp.

R304.5.3
