Access Compliance Report

Public Rights-of-Way

(Curb Ramps)

Intersection ID: N/A	Main Street: CITY_PARK_DR	Cross Street: NATIONAL_AV	Location: S
ADA ID: 213C93F4E932	Ramp Type: BlendTrans1	Initial Pass/Fail: Fail	Overall Compliance: No
		Severity Score: 10

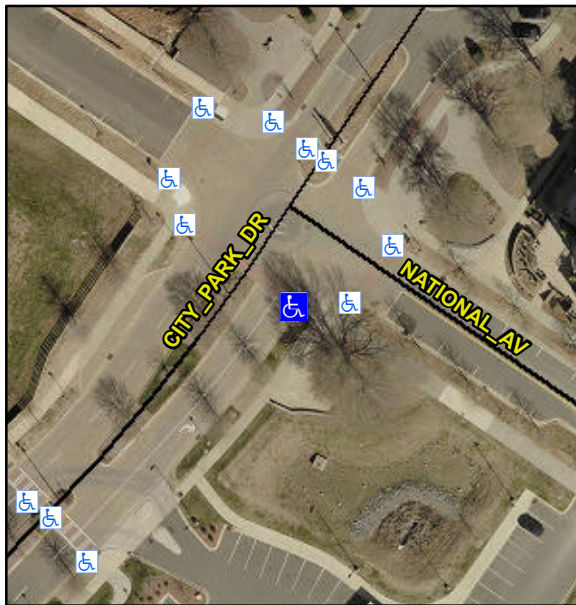
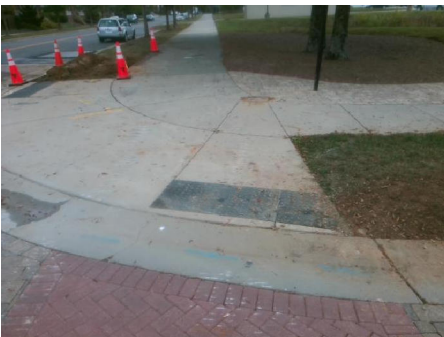
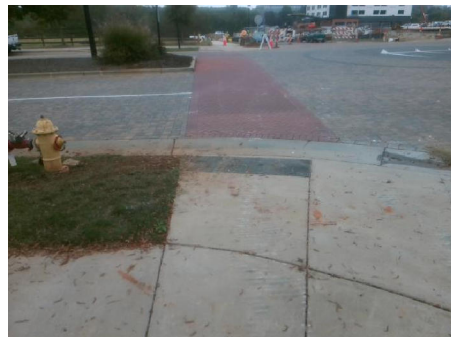
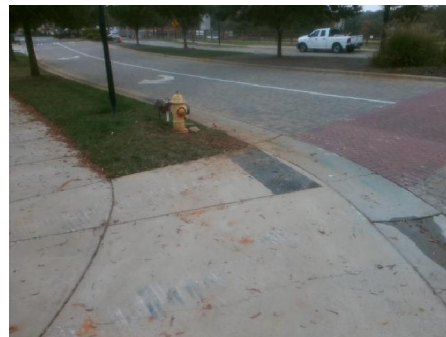
Not Found, R304.5.1

Compliance	Description	Data	Compliance	Description	Data
N/A	Ramp Length (in)	94.0	Yes	BlendTrans Slope (%)	1.9
No	Ramp Width (in)	46.0	Yes	BlendTrans XSlope (%)	3.0
N/A	Flare Type LT	N/A	N/A	Flare Type RT	N/A
N/A	Flare Slope LT (%)	N/A	N/A	Flare Slope RT (%)	N/A
N/A	Flare Traversable LT?	N/A	N/A	Flare Traversable RT?	N/A
N/A	Landing Length (in)	N/A	N/A	DWS Provided?	N/A
N/A	Landing Width (in)	N/A	N/A	DWS Contrast?	N/A
N/A	Landing Slope (%)	N/A	N/A	DWS Length (in)	N/A
N/A	Landing X Slope (%)	N/A	N/A	DWS Full Width?	N/A
N/A	Landing Curb? (Y/N)	N/A	N/A	DWS Offset (in)	N/A
N/A	Shared Landing?	N/A			
N/A	Gutter Ponding?	N/A	N/A	Gutter Slope (%)	N/A
N/A	Gutter Lip Ht (in)	N/A	N/A	Gutter X Slope (%)	N/A
N/A	Painted X Walk1?	Yes	N/A	Painted X Walk2?	N/A
	X Walk 1 Direction	To NW		X Walk 2 Direction	N/A
	X Walk 1 Width (in)	95.0		X Walk 2 Width (in)	N/A
	X Walk 1 Slope (%)	2.3		X Walk 2 Slope (%)	N/A
	X Walk 1 X Slope (%)	3.5		X Walk 2 X Slope (%)	N/A

N/A	Ramp inside XWalk1?	Yes	N/A	Ramp inside XWalk2?	N/A
	Road Slope (%)	3.5		Clear Space?	N/A
	Road X Slope (%)	2.3	N/A	Clear Space to XWalk (in)	N/A
N/A	Any Obstructions?	N/A	N/A	Storm Grate/Utility Hazard?	N/A
	Obstruction Type			Storm Grate/Utility Type	
		N/A			N/A
			Yes	Surface Condition? (G/P)	Good
			No	Curb Slope (%)	6.4

Remove & Replace Curb Ramp With Two New Directional Ramps or Equivalent.
