## Access Compliance Report Public Rights-of-Way (Curb Ramps)

Intersection ID: 52476 Main Street: WHITEHALL\_EXECUTIVE\_CENTERs\_DStreet: N/A Location: NE

ADA ID: 213F107B2E5A Ramp Type: Perp Initial Pass/Fail: Fail Overall Compliance: No Severity Score: 13.75

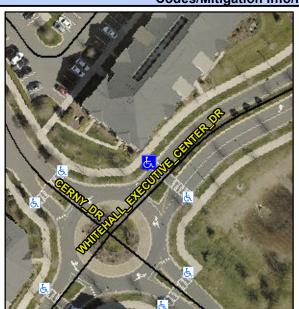
| POSSIDIE SOIULIOII | |
|---|---|
| R304.2.2, R304.5.3 | N/A |

| Field Measurements/Component Compliance | | | | | |
|---|---|---|---|---|---|
| N/A | Ramp Length (in) | 89.0 | No | Ramp Slope (%) | 8.9 |
| Yes | Ramp Width (in) | 95.0 | No | Ramp XSlope (%) | 4.0 |

| POSSIDIE SOIULIOII | |
|---|---|
| Remove & Replace Entire Ramp. | N/A |

| Total Cost: | \$<br>1850.00 |
