# Access Compliance Report

## Public Rights-of-Way

| Intersection ID: 23117 | Main Street: CEDAR_CROSSINGS_DR | Cross Street: ERWIN_RD | Location: SW |
| ADA ID: 214754512F0A | Ramp Type: PerpDiag | Initial Pass/Fail: Fail | Overall Compliance: No |

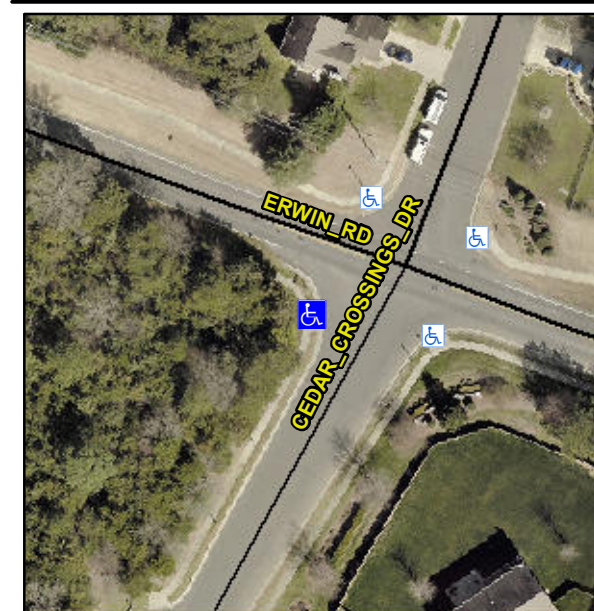
| Severity Score: 22.5 | | | |

| Compliance | Description | Data | Compliance | Description | Data |
|---|---|---|---|---|---|
| N/A | Ramp Length (in) | 48.0 | No | Ramp Slope (%) | 11.8 |
| No | Ramp Width (in) | 46.0 | No | Ramp XSlope (%) | 3.9 |

**Remove & Replace Curb Ramp With Two New Directional Ramps or Equivalent.**

**R304.5.1, R304.2.2, R304.5.3**

Total Cost: \$ 3200.00
