# Access Compliance Report

## Public Rights-of-Way

### (Curb Ramps)

| Intersection ID: 14340 | Main Street: GREENWOOD_CLIFF | Cross Street: KENILWORTH_AV | Location: E |

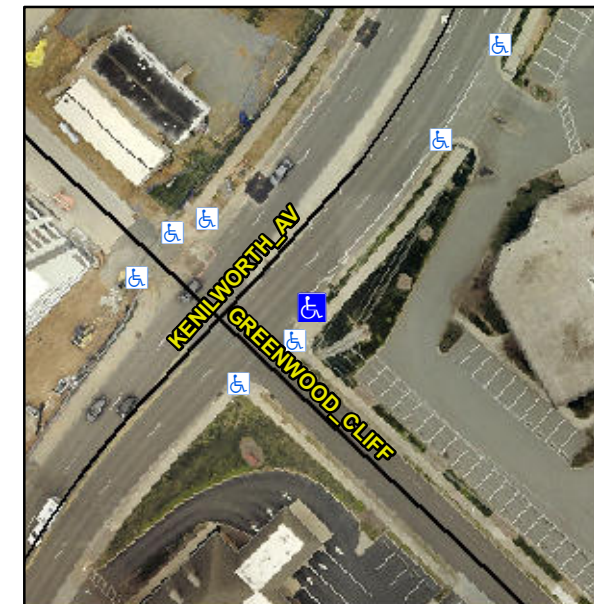
| ADA ID: 214D3C248ED1 | Ramp Type: Perp | Initial Pass/Fail: Pass | Overall Compliance: No |
| | | | Severity Score: 17.75 |

**Not Found, R304.5.3, R304.2.1,  
R304.2.2-Perp, R304.3.2-Para,  
R304.2.3, R304.5.4**

| Compliance | Description | Data | Compliance | Description | Data |
|---|---|---|---|---|---|
| Yes | Ramp Width (in) | 48.0 | No | Ramp XSlope (%) | 4.5 |
| N/A | Flare Slope LT (%) | 4.8 | No | Flare Slope RT (%) | 11.0 |
| Yes | Gutter Ponding? | No | No | Gutter Slope (%) | 6.9 |
| Yes | Gutter Lip Ht (in) | 0.0 | No | Gutter X Slope (%) | 3.3 |

**Remove & Replace Entire Ramp.  
Remove & Replace Gutter.**

Total Cost: \$ 2600.00
