Access Compliance Report

Public Rights-of-Way

(Curb Ramps)

Intersection ID: 5523	Main Street: MALLARD_PARK_DR	Cross Street: PINE_BRANCH_CT	Location: S
ADA ID: 214F08DD1AC3	Ramp Type: Perp	Initial Pass/Fail: Fail	Overall Compliance: No
		Severity Score: 35

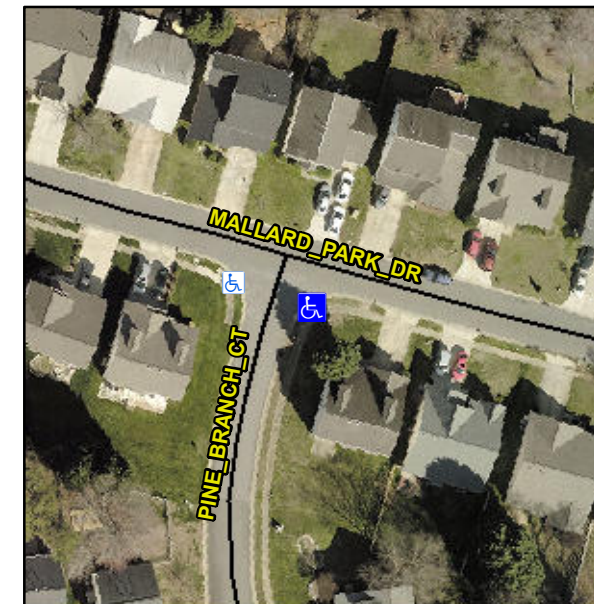
Not Found, R304.5.1

Compliance	Description	Data	Compliance	Description	Data
N/A	Ramp Length (in)	97.0	Yes	Ramp Slope (%)	7.7
No	Ramp Width (in)	29.0	Yes	Ramp XSlope (%)	0.9
N/A	Flare Type LT	N/A	N/A	Flare Type RT	N/A
N/A	Flare Slope LT (%)	N/A	N/A	Flare Slope RT (%)	N/A
N/A	Flare Traversable LT?	N/A	N/A	Flare Traversable RT?	N/A
N/A	Landing Length (in)	N/A	N/A	DWS Provided?	N/A
N/A	Landing Width (in)	N/A	N/A	DWS Contrast?	N/A
N/A	Landing Slope (%)	N/A	N/A	DWS Length (in)	N/A
N/A	Landing X Slope (%)	N/A	N/A	DWS Full Width?	N/A
N/A	Landing Curb? (Y/N)	N/A	N/A	DWS Offset (in)	N/A
N/A	Shared Landing?	N/A			
N/A	Gutter Ponding?	N/A	N/A	Gutter Slope (%)	N/A
N/A	Gutter Lip Ht (in)	N/A	N/A	Gutter X Slope (%)	N/A
N/A	Painted X Walk1?	No	N/A	Painted X Walk2?	N/A
	X Walk 1 Direction	To NW		X Walk 2 Direction	N/A
N/A	X Walk 1 Width (in)	N/A	N/A	X Walk 2 Width (in)	N/A
	X Walk 1 Slope (%)	5.4		X Walk 2 Slope (%)	N/A
	X Walk 1 X Slope (%)	0.5		X Walk 2 X Slope (%)	N/A

N/A	Ramp inside XWalk1?	N/A	N/A	Ramp inside XWalk2?	N/A
	Road Slope (%)	N/A	N/A	Clear Space?	N/A
	Road X Slope (%)	N/A	N/A	Clear Space to XWalk (in)	N/A
N/A	Any Obstructions?	N/A	N/A	Storm Grate/Utility Hazard?	N/A
	Obstruction Type			Storm Grate/Utility Type	
		N/A			N/A
			Yes	Surface Condition? (G/P)	Good

Remove & Replace Entire Ramp.
