Access Compliance Report

Public Rights-of-Way

(Curb Ramps)

Intersection ID: 13559	Main Street: W_WORTHINGTON_AV	Cross Street: WEST_BV	Location: NE
ADA ID: 2150DF7D8F8A	Ramp Type: Perp	Initial Pass/Fail: Fail	Overall Compliance: No
		Severity Score: 35

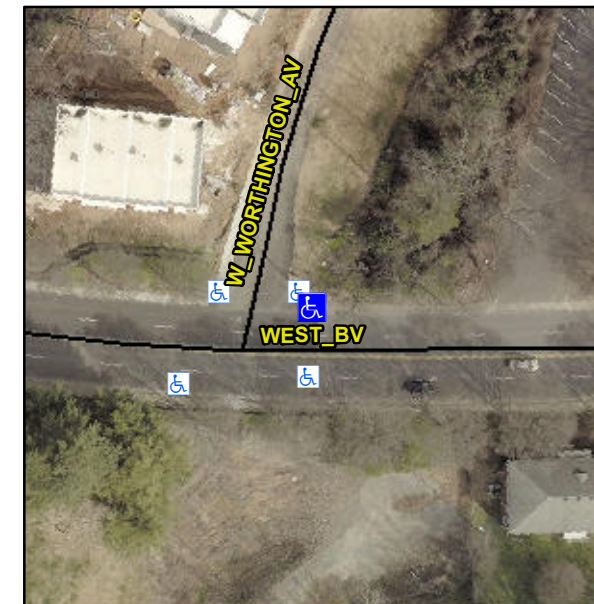
Not Found, R304.5.1, R304.2.2

Compliance	Description	Data	Compliance	Description	Data
N/A	Ramp Length (in)	41.0	No	Ramp Slope (%)	14.9
No	Ramp Width (in)	40.0	Yes	Ramp XSlope (%)	2.3
N/A	Flare Type LT	N/A	N/A	Flare Type RT	N/A
N/A	Flare Slope LT (%)	N/A	N/A	Flare Slope RT (%)	N/A
N/A	Flare Traversable LT?	N/A	N/A	Flare Traversable RT?	N/A
N/A	Landing Length (in)	N/A	N/A	DWS Provided?	N/A
N/A	Landing Width (in)	N/A	N/A	DWS Contrast?	N/A
N/A	Landing Slope (%)	N/A	N/A	DWS Length (in)	N/A
N/A	Landing X Slope (%)	N/A	N/A	DWS Full Width?	N/A
N/A	Landing Curb? (Y/N)	N/A	N/A	DWS Offset (in)	N/A
N/A	Shared Landing?	N/A			
N/A	Gutter Ponding?	N/A	N/A	Gutter Slope (%)	N/A
N/A	Gutter Lip Ht (in)	N/A	N/A	Gutter X Slope (%)	N/A
N/A	Painted X Walk1?	No	N/A	Painted X Walk2?	N/A
	X Walk 1 Direction	To SW		X Walk 2 Direction	N/A
N/A	X Walk 1 Width (in)	N/A	N/A	X Walk 2 Width (in)	N/A
	X Walk 1 Slope (%)	1.4		X Walk 2 Slope (%)	N/A
	X Walk 1 X Slope (%)	2.4		X Walk 2 X Slope (%)	N/A

N/A	Ramp inside XWalk1?	N/A	N/A	Ramp inside XWalk2?	N/A
	Road Slope (%)	N/A	N/A	Clear Space?	N/A
	Road X Slope (%)	N/A	N/A	Clear Space to XWalk (in)	N/A
N/A	Any Obstructions?	N/A	N/A	Storm Grate/Utility Hazard?	N/A
	Obstruction Type			Storm Grate/Utility Type	
		N/A			N/A
			Yes	Surface Condition? (G/P)	Good

Remove & Replace Entire Ramp.

Total Cost: \$ 1850.00
