Access Compliance Report

Public Rights-of-Way

(Curb Ramps)

Intersection ID: 20702	Main Street: ARCHDALE_DR	Cross Street: PARKSTONE_DR	Location: NE
ADA ID: 216508A9FBFE	Ramp Type: PerpDiag	Initial Pass/Fail: Fail	Overall Compliance: No
Severity Score: 8.75			
Codes/Mitigation Info/Possible Solution		Field Measurements/Component Compliance

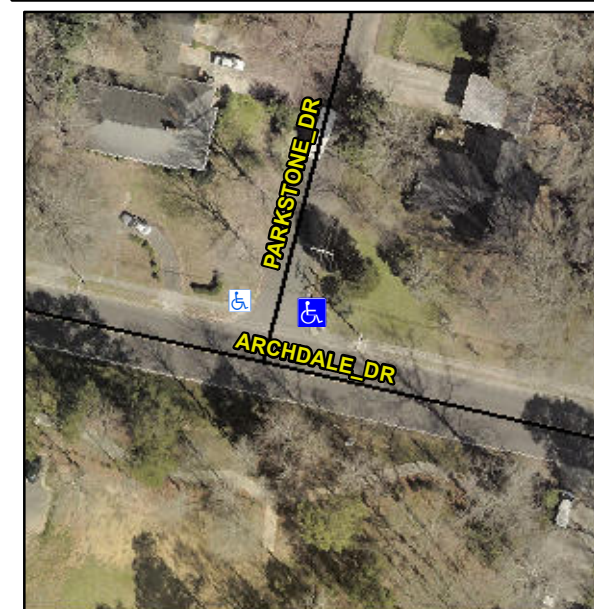
Compliance	Description	Data	Compliance	Description	Data
N/A	Ramp Length (in)	59.0	Yes	Ramp Slope (%)	6.1
No	Ramp Width (in)	46.0	Yes	Ramp XSlope (%)	1.9
N/A	Flare Type LT	N/A	N/A	Flare Type RT	N/A
N/A	Flare Slope LT (%)	N/A	N/A	Flare Slope RT (%)	N/A
N/A	Flare Traversable LT?	N/A	N/A	Flare Traversable RT?	N/A
N/A	Landing Length (in)	N/A	N/A	DWS Provided?	N/A
N/A	Landing Width (in)	N/A	N/A	DWS Contrast?	N/A
N/A	Landing Slope (%)	N/A	N/A	DWS Length (in)	N/A
N/A	Landing X Slope (%)	N/A	N/A	DWS Full Width?	N/A
N/A	Landing Curb? (Y/N)	N/A	N/A	DWS Offset (in)	N/A
N/A	Shared Landing?	N/A			
N/A	Gutter Ponding?	N/A	N/A	Gutter Slope (%)	N/A
N/A	Gutter Lip Ht (in)	N/A	N/A	Gutter X Slope (%)	N/A
N/A	Painted X Walk1?	No	N/A	Painted X Walk2?	No
	X Walk 1 Direction	To W		X Walk 2 Direction	To S
N/A	X Walk 1 Width (in)	N/A	N/A	X Walk 2 Width (in)	N/A
	X Walk 1 Slope (%)	2.4		X Walk 2 Slope (%)	13.3
	X Walk 1 X Slope (%)	6.1		X Walk 2 X Slope (%)	1.2

N/A	Ramp inside XWalk1?	N/A	N/A	Ramp inside XWalk2?	N/A
	Road Slope (%)	4.0	N/A	Clear Space?	N/A
	Road X Slope (%)	9.4	N/A	Clear Space to XWalk (in)	N/A
N/A	Any Obstructions?	N/A	N/A	Storm Grate/Utility Hazard?	N/A
	Obstruction Type			Storm Grate/Utility Type	
		N/A			N/A
		Yes		Surface Condition? (G/P)	Good

Possible Solutions:

Remove & Replace Curb Ramp With Two New Directional Ramps or Equivalent.

R304.5.1
