# Access Compliance Report

## Public Rights-of-Way

### (Curb Ramps)

Intersection ID: 43083	Main Street: N_KINGS_DR	Cross Street: ARMORY_DR	Location: SE
ADA ID: 216D9314E01B	Ramp Type: Perp	Initial Pass/Fail: Fail	Overall Compliance: No
Severity Score: 22.5			
Codes/Mitigation Info/Possible Solution		Field Measurements/Component Compliance

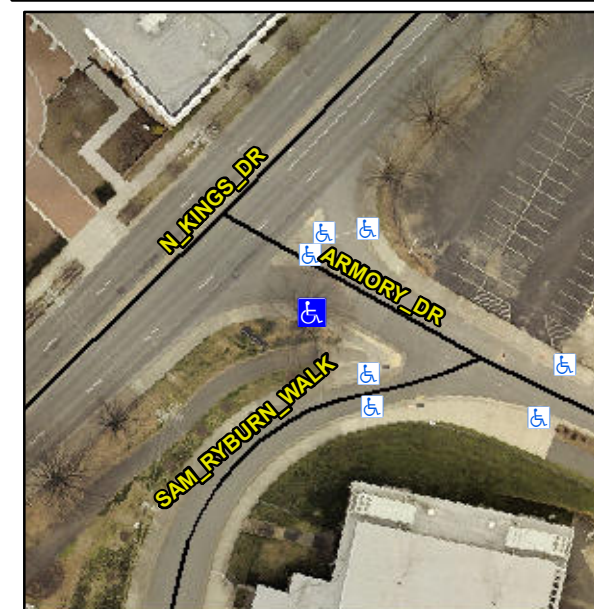
**Not Found, R304.5.1, R304.2.2, R304.5.3**

Compliance	Description	Data	Compliance	Description	Data
N/A	Ramp Length (in)	50.0	No	Ramp Slope (%)	9.7
No	Ramp Width (in)	41.0	No	Ramp XSlope (%)	2.3
N/A	Flare Type LT	N/A	N/A	Flare Type RT	N/A
N/A	Flare Slope LT (%)	N/A	N/A	Flare Slope RT (%)	N/A
N/A	Flare Traversable LT?	N/A	N/A	Flare Traversable RT?	N/A
N/A	Landing Length (in)	N/A	N/A	DWS Provided?	N/A
N/A	Landing Width (in)	N/A	N/A	DWS Contrast?	N/A
N/A	Landing Slope (%)	N/A	N/A	DWS Length (in)	N/A
N/A	Landing X Slope (%)	N/A	N/A	DWS Full Width?	N/A
N/A	Landing Curb? (Y/N)	N/A	N/A	DWS Offset (in)	N/A
N/A	Shared Landing?	N/A			
N/A	Gutter Ponding?	N/A	N/A	Gutter Slope (%)	N/A
N/A	Gutter Lip Ht (in)	2.0	N/A	Gutter X Slope (%)	N/A
N/A	Painted X Walk1?	No	N/A	Painted X Walk2?	N/A
	X Walk 1 Direction	To N		X Walk 2 Direction	N/A
N/A	X Walk 1 Width (in)	N/A	N/A	X Walk 2 Width (in)	N/A
	X Walk 1 Slope (%)	5.0		X Walk 2 Slope (%)	N/A
	X Walk 1 X Slope (%)	0.3		X Walk 2 X Slope (%)	N/A

**Remove & Replace Entire Ramp.**

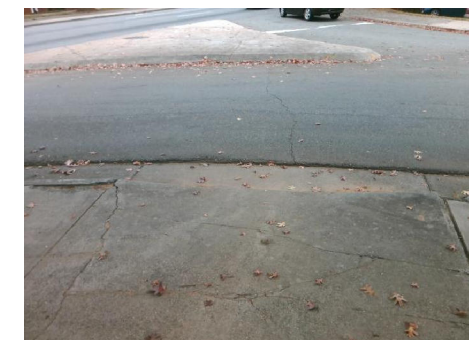
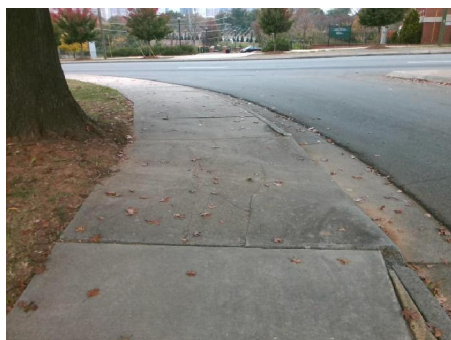
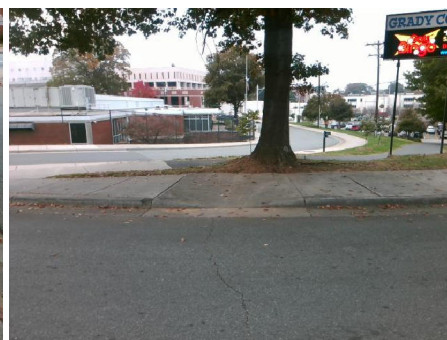
N/A	Ramp inside XWalk1?	N/A	N/A	Ramp inside XWalk2?	N/A
	Road Slope (%)	N/A	N/A	Clear Space?	N/A
	Road X Slope (%)	N/A	N/A	Clear Space to XWalk (in)	N/A
N/A	Any Obstructions?	N/A	N/A	Storm Grate/Utility Hazard?	N/A
	Obstruction Type			Storm Grate/Utility Type	
		N/A			N/A
			Yes	Surface Condition? (G/P)	Good
