Access Compliance Report

Public Rights-of-Way

(Curb Ramps)

Intersection ID: 16365	Main Street: QUEENS_RD	Cross Street: SHERWOOD_AV	Location: NE
ADA ID: 216DAB1C8803	Ramp Type: Directional1	Initial Pass/Fail: Fail	Overall Compliance: No
Codes/Mitigation Info/Possible Solution		Field Measurements/Component Compliance	
Severity Score: 13.75

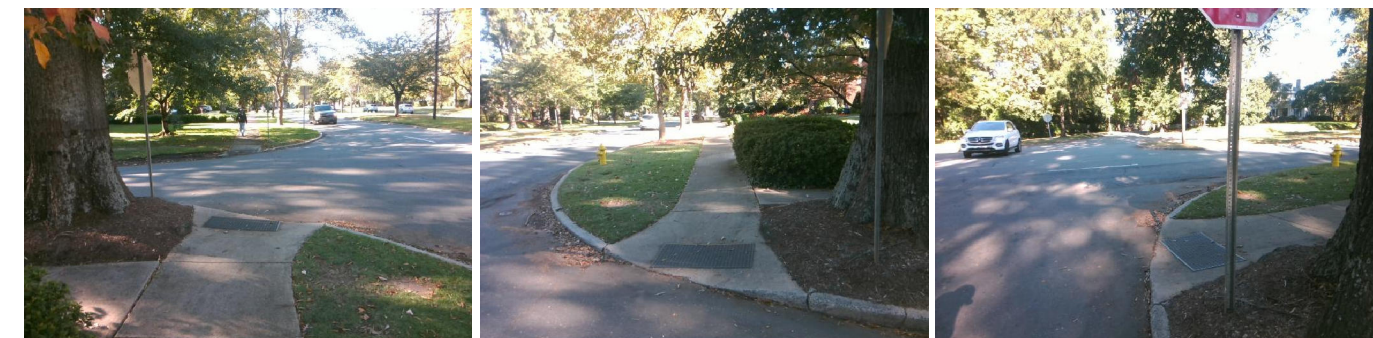
Possible Solutions:						
	Remove & Replace Entire Ramp.						
<p>Surveyor Notes:</p> <p>N/A</p>	<p>PROW/ADA:</p> <p>R304.2.2, R304.5.3</p>	Compliance	Description	Data	Compliance	Description	Data
		N/A	Ramp Length (in)	78.0	N/A	Grade Break?	N/A
<p>Street 1 Name</p> <p>SHERWOOD AV</p>	<p>Stop Condition-Street 1</p> <p>StopSign</p>	Yes	Ramp Width (in)	48.0	N/A	Grade Break Slope (%)	0.0
		No	Ramp Slope (%)	9.1	N/A	Grade Break XSlope (%)	0.0
<p>Street 2 Name</p> <p>N/A</p>	<p>Stop Condition-Street 2</p> <p>N/A</p>	No	Ramp XSlope (%)	2.4	N/A	Flare Type RT	N/A
		N/A	Flare Type LT	N/A	N/A	Flare Slope RT (%)	0.0
<p>Total Cost:</p> <p>\$ 1600.00</p>		N/A	Flare Slope LT (%)	N/A	N/A	Flare Traversable RT?	N/A
		N/A	Flare Traversable LT?	N/A	N/A	DWS Provided?	N/A
		N/A	Landing Length (in)	0.0	N/A	DWS Contrast?	N/A
		N/A	Landing Width (in)	0.0	N/A	DWS Length (in)	N/A
		N/A	Landing Slope (%)	0.0	N/A	DWS Full Width?	N/A

N/A	Landing X Slope (%)	0.0	N/A	DWS Offset LT (in)	N/A
		N/A	Landing Curb? (Y/N)	N/A	N/A	DWS Offset RT (in)	N/A
		N/A	Shared Landing?	N/A	N/A	Gutter Slope (%)	N/A
		N/A	Gutter Ponding?	0.0	N/A	Gutter X Slope (%)	N/A
		N/A	Gutter Lip Ht (in)	0.0	N/A	Road Slope (%)	0.0
		N/A	Painted X Walk1?	No	N/A	Road X Slope (%)	4.9
		N/A	X Walk 1 Direction	To S	N/A	Clear Space?	N/A
		N/A	X Walk 1 Width (in)	N/A	N/A	Clear Space to XWalk (in)	N/A
		N/A	X Walk 1 Slope (%)	0.0	N/A	Storm Grate/Utility Hazard?	N/A
		N/A	X Walk 1 X Slope (%)	4.9	N/A	Storm Grate/Utility Type	N/A
		N/A	Ramp inside XWalk1?	N/A	N/A	Surface Condition? (G/P)	Good
		N/A	Any Obstructions?	N/A	N/A	Curb Slope (%)	10.4
		N/A	Obstruction Type		N/A
